**TECHNICAL INFORMATION REPORT
FOR
MILL CREEK INDUSTRIAL WAREHOUSE**

**City of Mill Creek File No.
Eastside Consultants, Inc. File No. 23116**

October 10, 2024

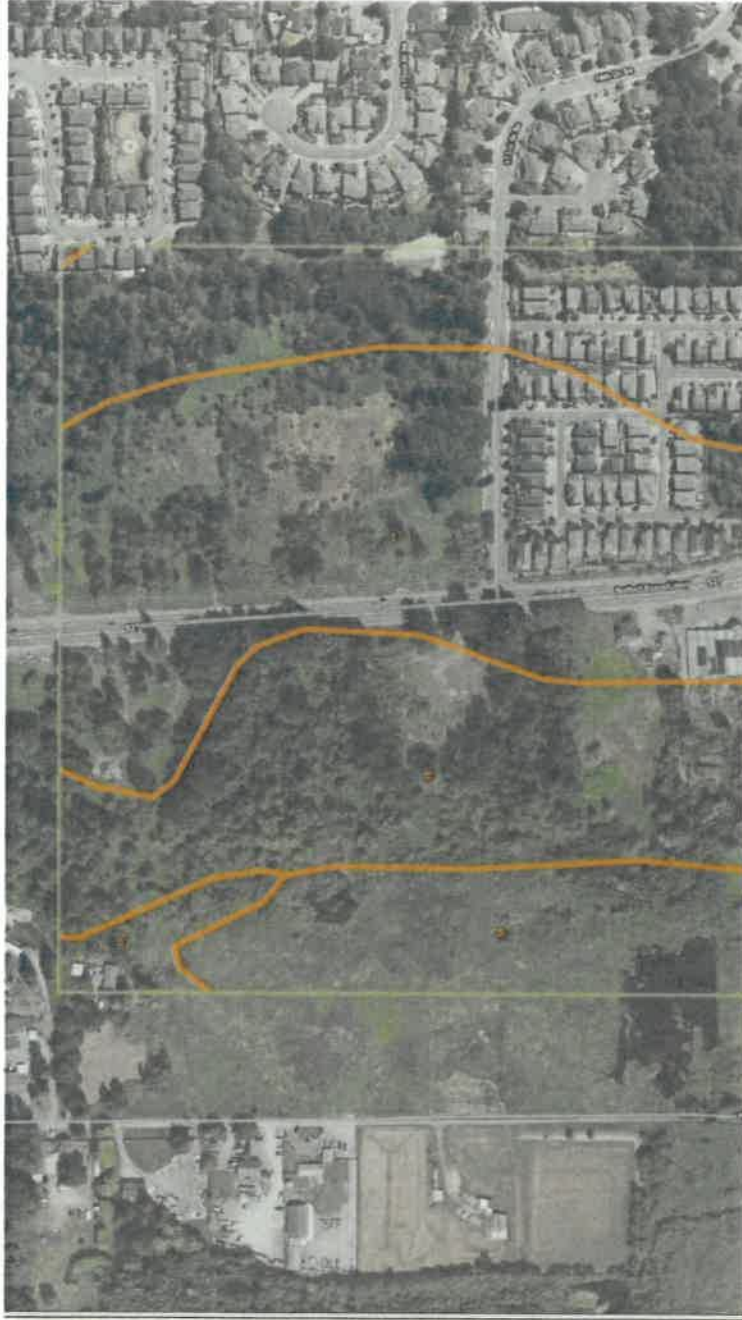
SOILS MAP
(Web Soil Survey from USDA NRCS)

Snohomish County Area, Washington (WA661) Snohomish County Area, Washington (WA661)				
Map Unit Symbol	Map Unit Name	Acres in AOI	Percent of AOI	
1	Alderwood gravelly sandy loam, 0 to 8 percent slopes	0.0	0.0%	
2	Alderwood gravelly sandy loam, 8 to 15 percent slopes	0.0	0.1%	
3	Alderwood gravelly sandy loam, 15 to 30 percent slopes	12.0	18.2%	
17	Everett very gravelly sandy loam, 0 to 8 percent slopes	28.4	43.0%	
18	Everett very gravelly sandy loam, 8 to 15 percent slopes	16.9	25.6%	
34	Mukilteo muck	8.7	13.2%	
Totals for Area of Interest		66.2	100.0%
