## **Preliminary Geotechnical Study**

DRCC Property Master Plan  
Mill Creek, Washington

File No. 6431-002-00

May 18, 2023

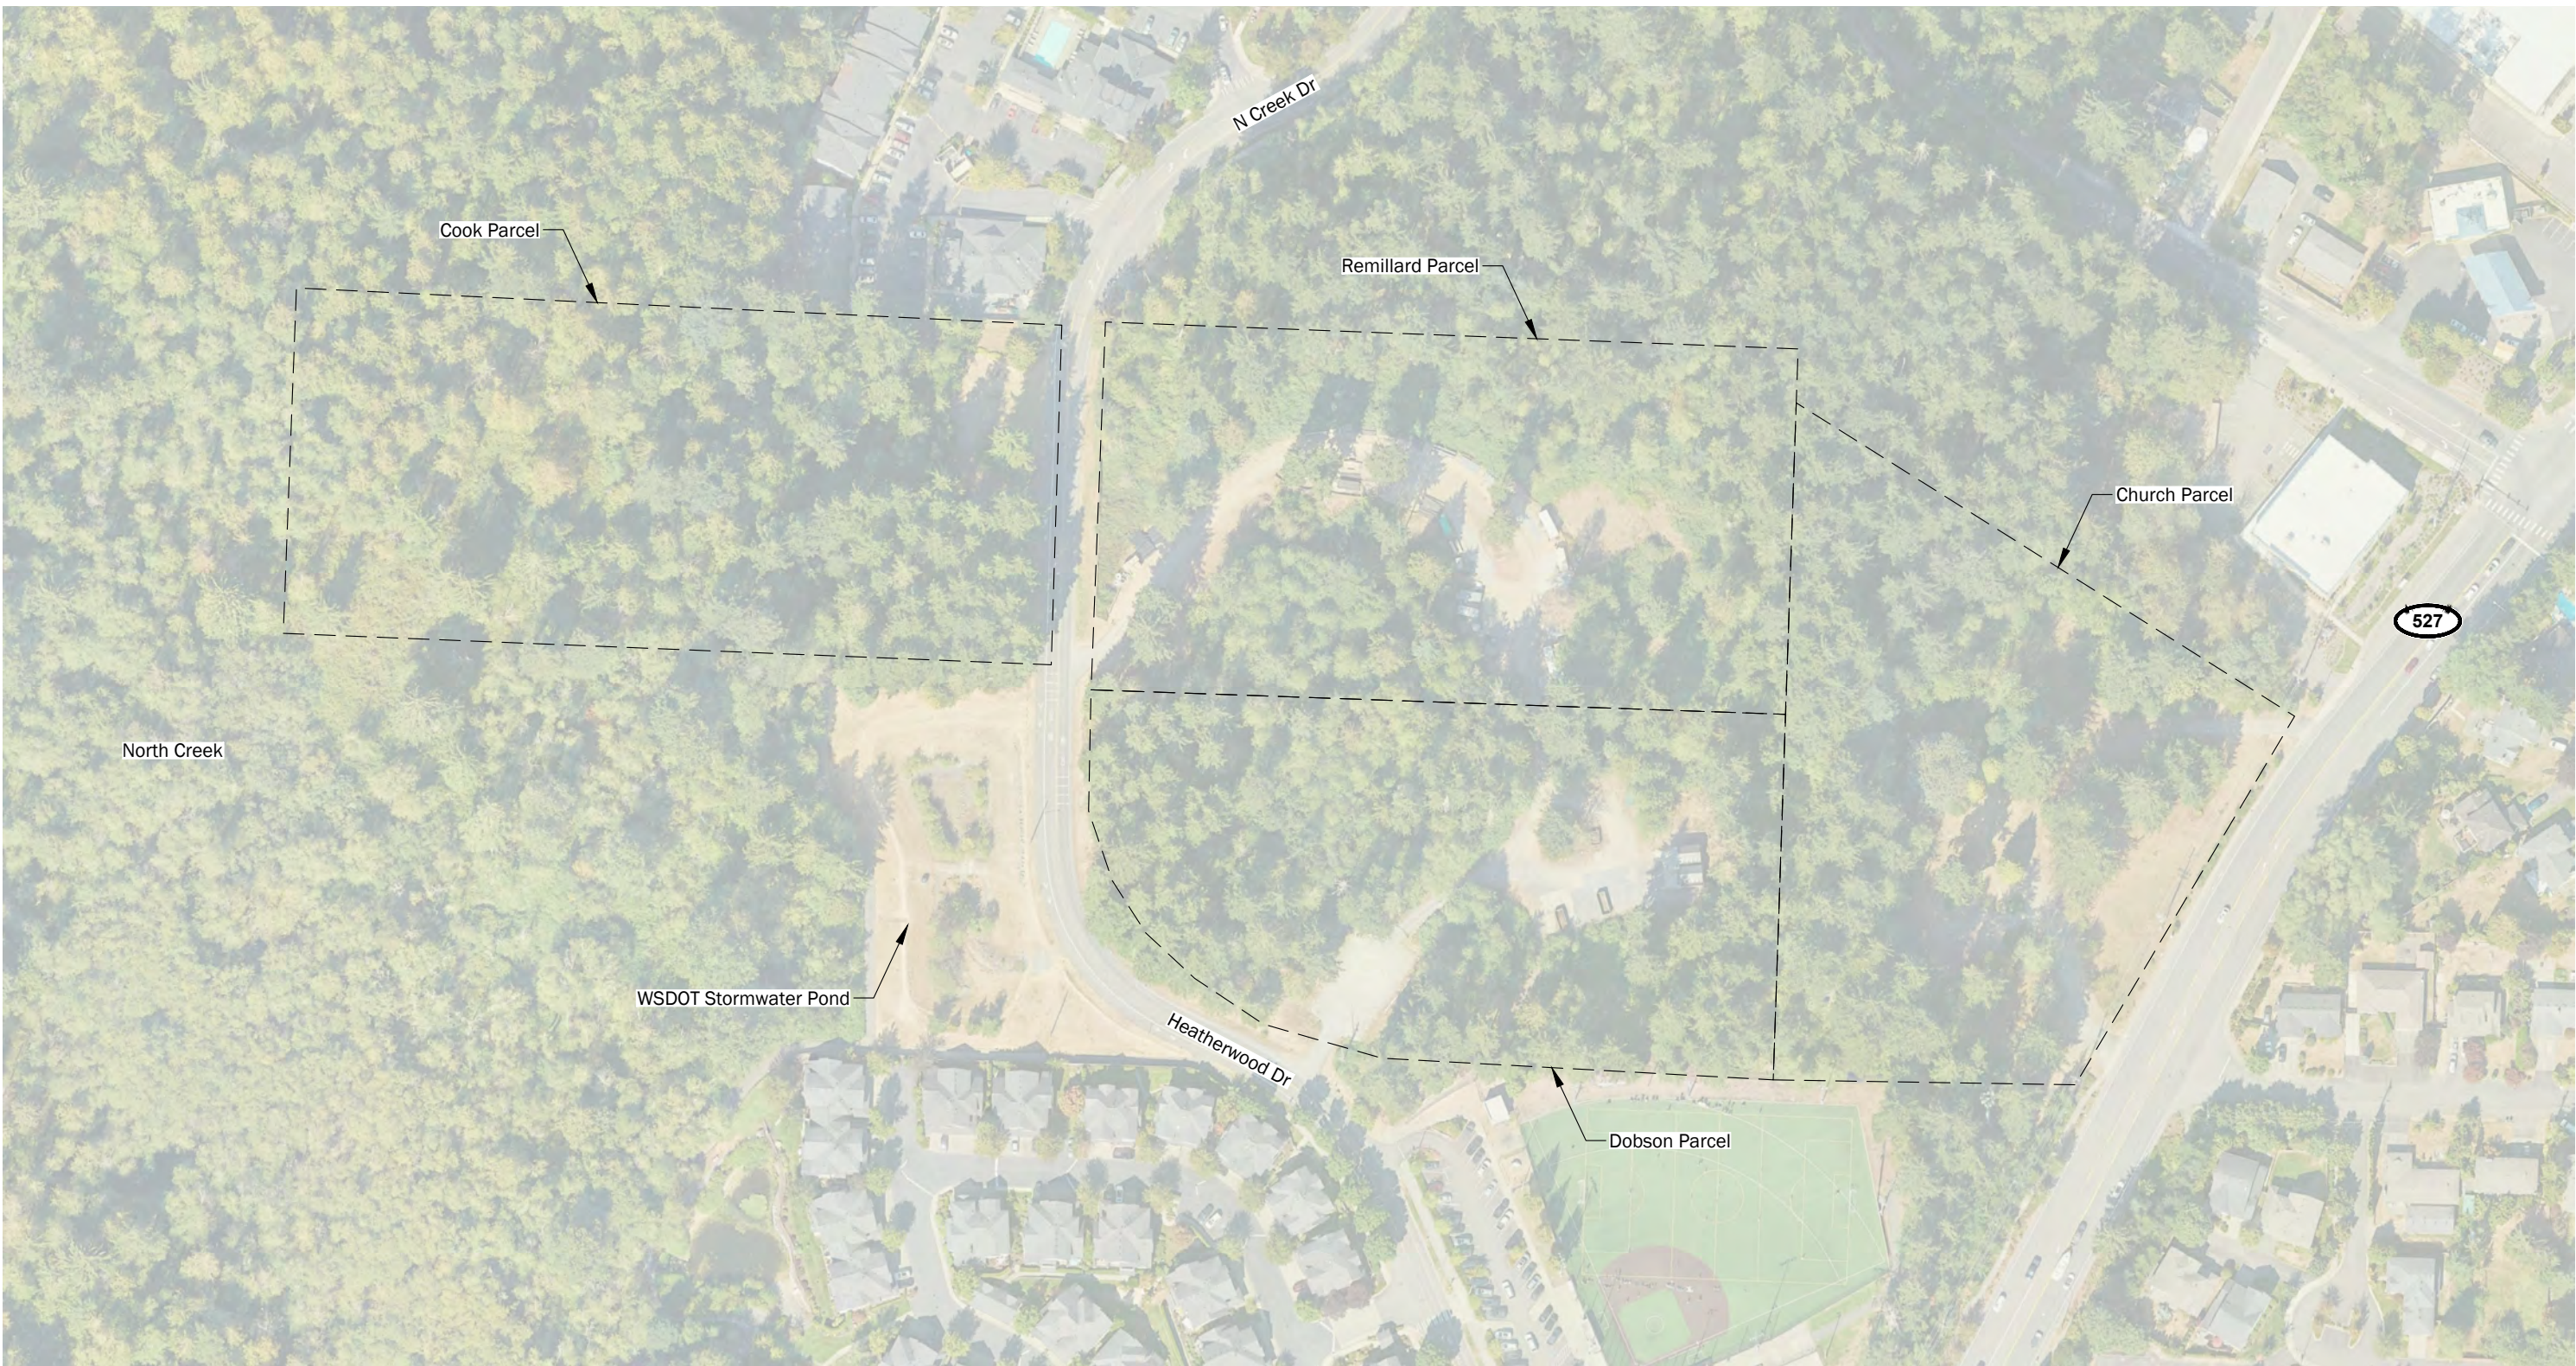
P:\6431002\CAD\00\Geotech Report\643100200\_F02-F03\_Site Plan and Historic Site Photo.dwg F02 Date Exported:5/16/2023 11:57 AM - by Gabby Register

Data Source: Aerial from Google Earth Pro dated 08/23/2022.

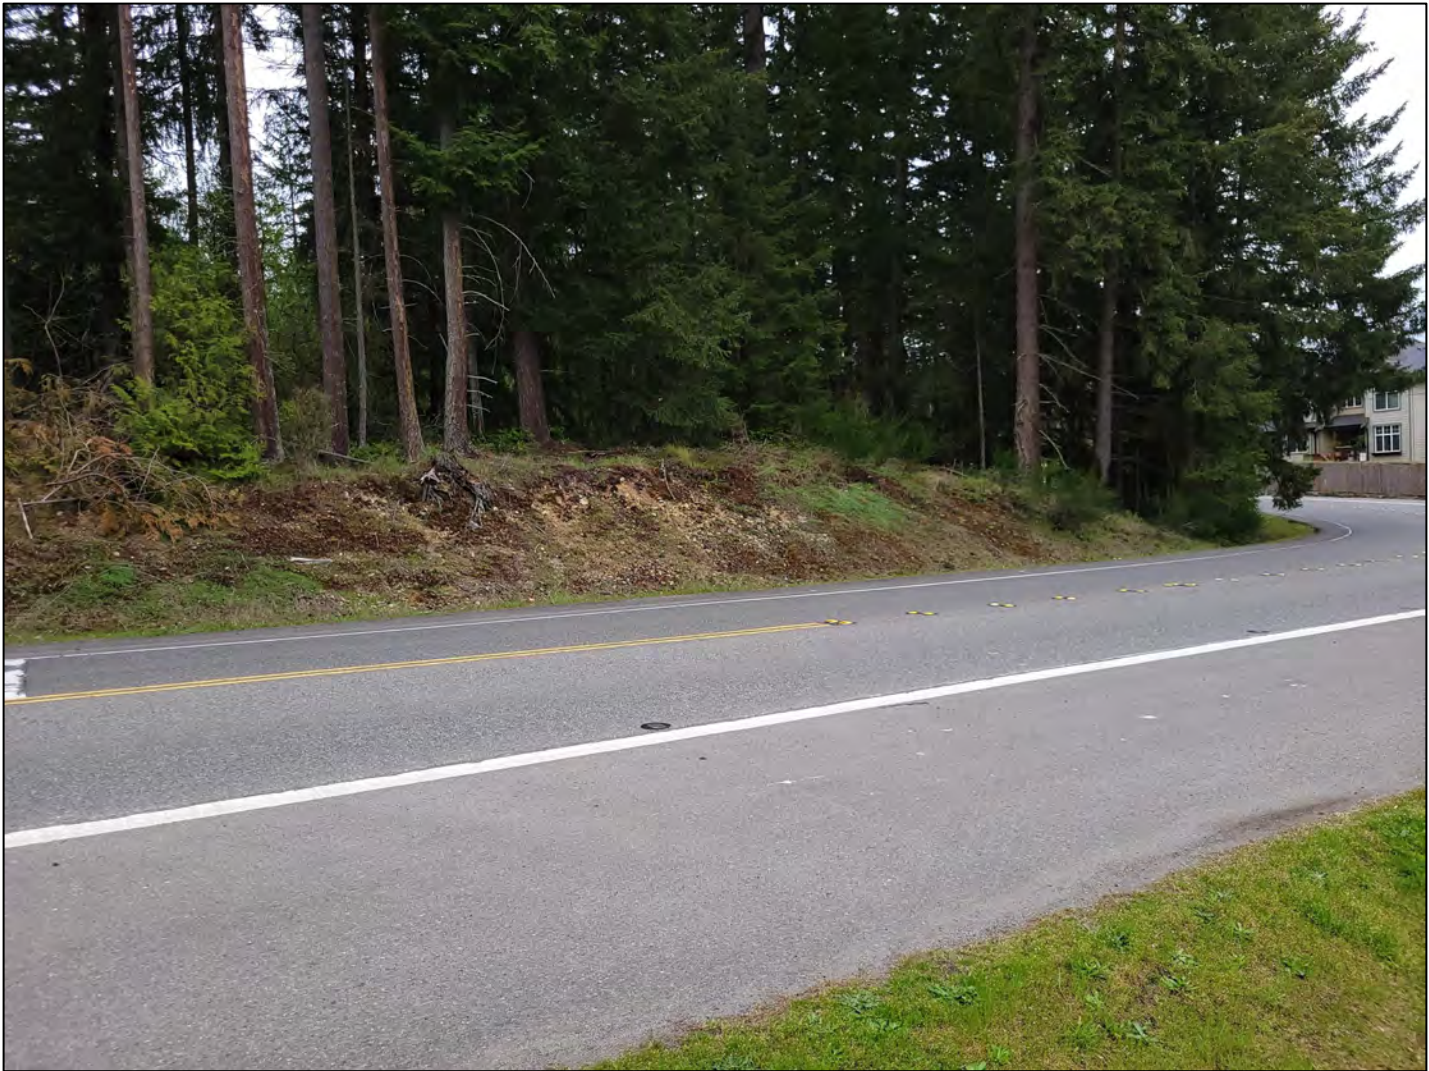
| | Figure 4 |

Dobson property, as seen from North Creek Drive looking generally southeast. Example of typical dense forestation in project area with mature trees and undergrowth vegetation. Also note existing slope and exposed soils at roadway grading cut.

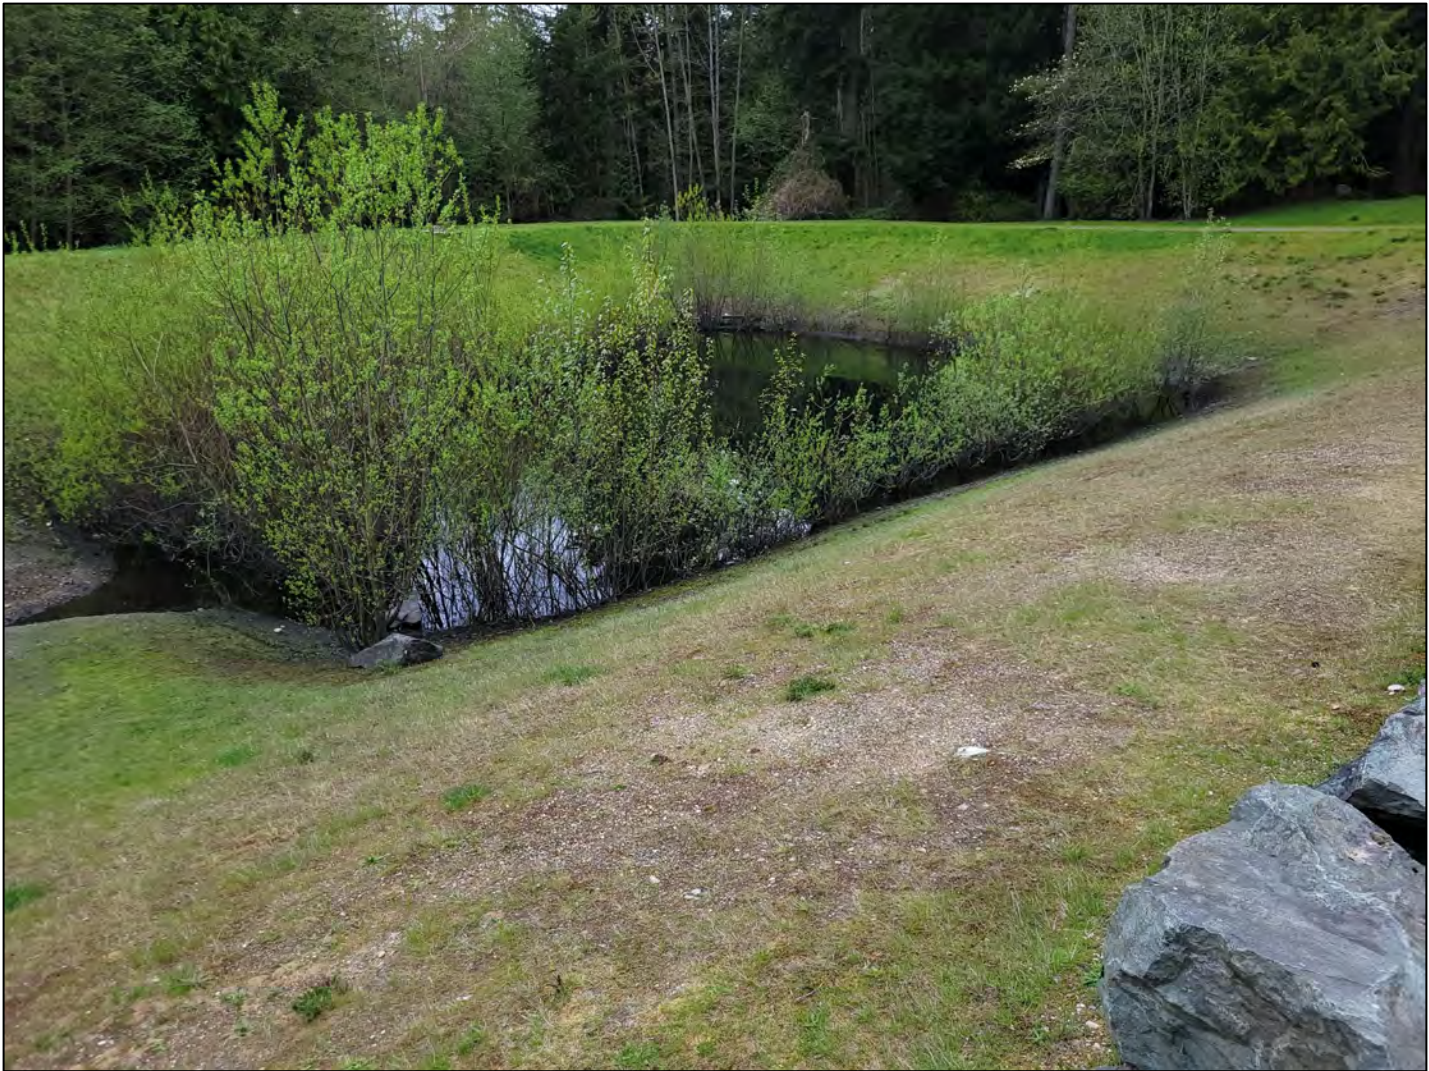
| | Figure 5 |

WSDOT stormwater pond looking generally northwest. Note standing water and young trees at bottom of pond.

Immediately to the southwest of the Remillard Parcel, a WSDOT stormwater management pond is present. We observed young trees and standing water present at the base of the pond during our visit.

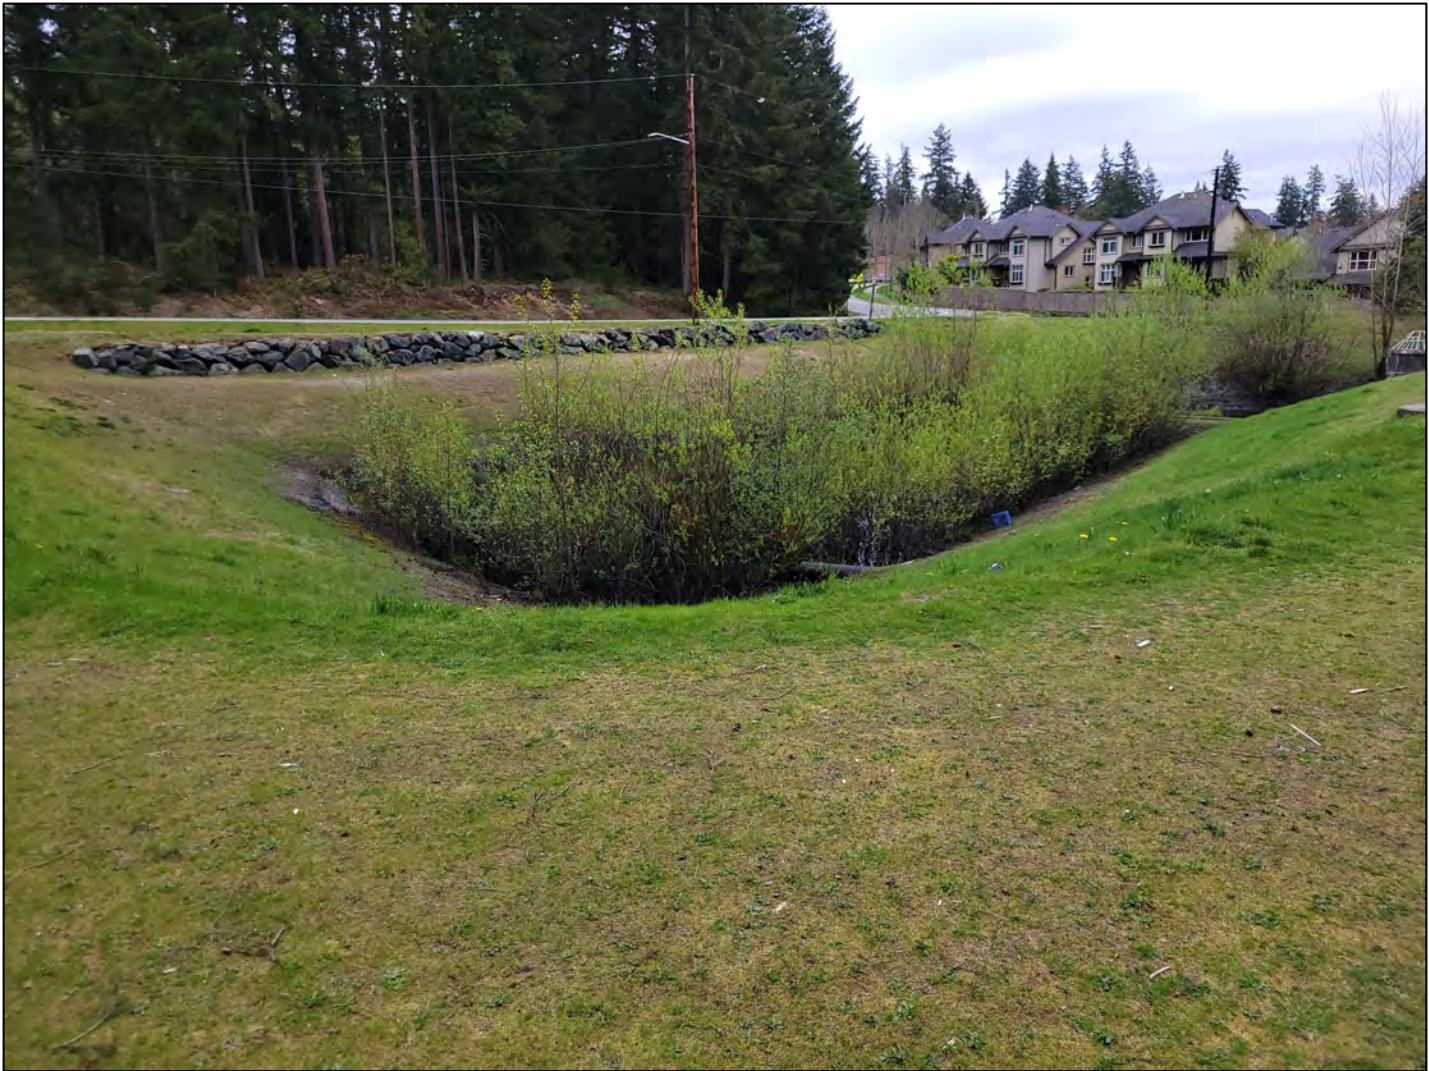
WSDOT stormwater pond looking generally southeast. Note rockery wall adjacent to North Creek Drive and young trees in bottom of pond.
