# CRITICAL AREAS STUDY AND MITIGATION PLAN

# 13209 BOTHELL EVERETT HWY MUTTLEY SQUARE SEATTLE, WA

Wetland Resources, Inc. Project #16263

Revision: November 28, 2018

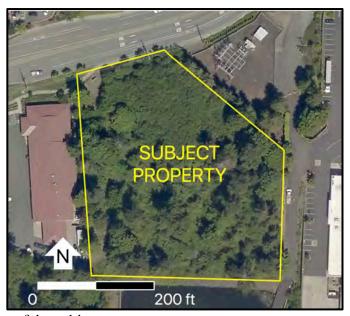
**Figure 1:** Aerial view of the subject property

The subject site is a 2.68-acre parcel located at 13209 Bothell Everett Highway in the City of Mill Creek, Washington, (parcel #: 28053100100400) within a portion of Section 31, Township 28N, Range 5E, W.M. Access to the subject site is from the northeast via 132nd Street SE. Surrounding land use consists primarily of large commercial centers and dense suburban residences within a heavily developed area. A PUD power substation lies immediately northeast of the site, a Lowes shopping center to the east, a detention pond to the south, and an automotive business to the west. On-site topography varies, sloping down to the southwest overall. However, a small depressional area is present near the center of the site, and a low swale is in the northwestern corner.

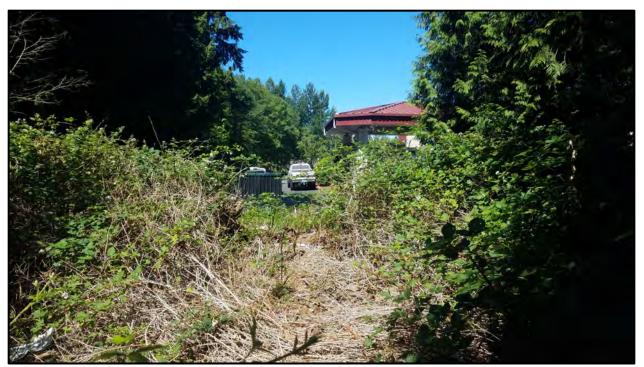
**Figure 2:** Photo taken from stormwater pond, facing the automotive facility

The off-site wetland located southwest of the subject site is a large forested and scrub-shrub system that appears to be permanently flooded. Lack of access prevented us from delineating or rating this critical area. An existing automotive repair facility and large stormwater detention pond (fenced) bisect the area between the subject parcel and the off-site wetland. Only a very small (<50 foot) gap is between these intervening structures. However, even the gap area is highly disturbed with a dirt roadway between the wetland and the proposed development area. Given these existing conditions, the subject site is not contiguous with the off-site critical area and is unable to provide functions or protections. As such, it has been determined that any buffer associate with the off-site wetland does not extend into the project area. This is consistent with the definition of buffer in MCMC 18.06.210, which is provided below. Therefore, the wetland category is not germane to this project.

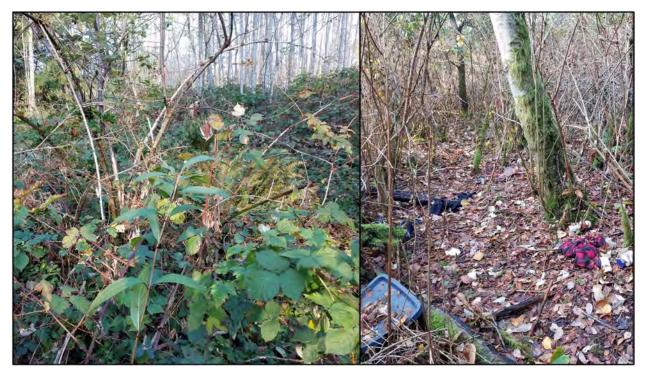
Figure 3: Degraded conditions in the proposed buffer averaging reduction area.

Areas provided as additional buffer are of higher quality compared to that being removed. The area of buffer proposed for reduction through averaging is degraded by human refuse, low habitat heterogeneity, and invasive vegetation such as Himalayan blackberry (see figure 3). In contrast, the portion of the buffer being provided through averaging is a complex, multi-story forest community with little to no invasive plant cover (see figure 4). Overall vegetation structure and habitat complexity within the wetland buffer will be increased through the proposed buffer averaging, and buffer functionality is expected to be improve. Photographs of these areas are provided below.

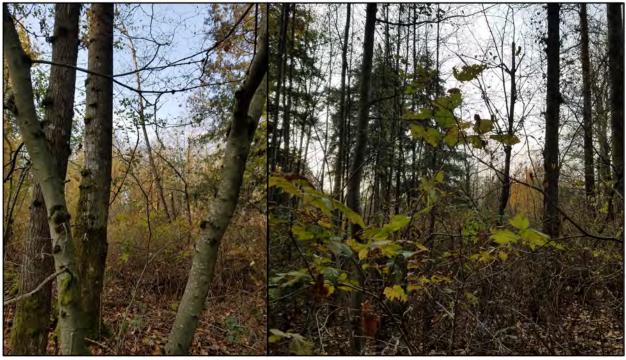
**Figure 4:** Healthy, multi-story forest conditions in the proposed buffer averaging addition area.
