**WETLAND AND FISH AND WILDLIFE HABITAT  
ASSESSMENT REPORT AND BUFFER AVERAGING AND  
ENHANCEMENT PLAN**

**CRESTVIEW VILLAGE II**

2316 132ND STREET SOUTHEAST  
MILL CREEK, WASHINGTON 98012

#### **SOUNDVIEW CONSULTANTS LLC**

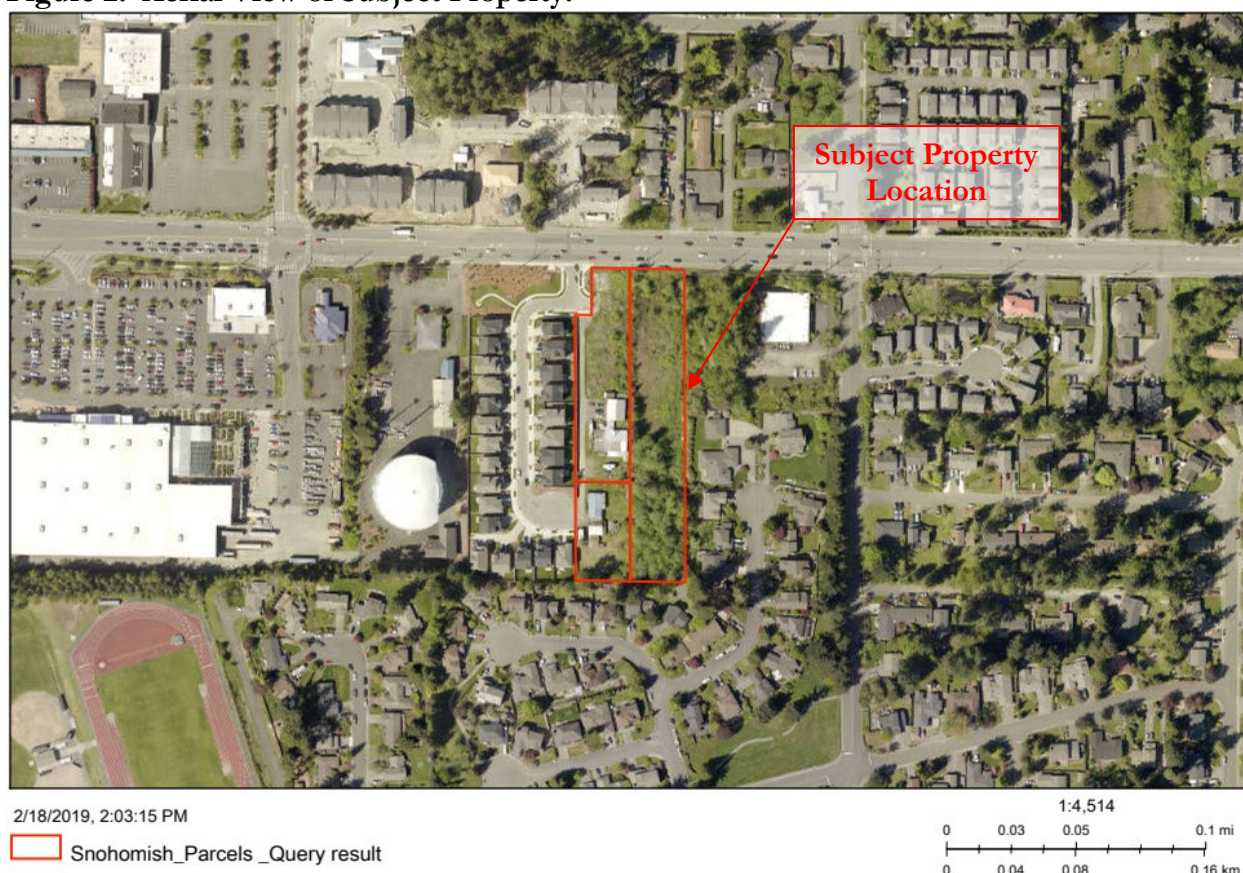
**Figure 2. Aerial View of Subject Property.**

The 3.23-acre subject property is located in an urban residential/commercial setting in the City of Mill Creek, Washington and is currently developed with two single-family residences and associated infrastructure (Figure 2). The subject property is bounded by 132<sup>nd</sup> Street Southeast to the north; single-family residences to the west and south; and a commercial facility and single-family residences to the east. Topography on the subject property is relatively flat between approximate elevations of 480 to 485 feet above mean sea level (Appendix B3). The site is located within the Snohomish watershed, or Water Resource Inventory Area (WRIA) 8.

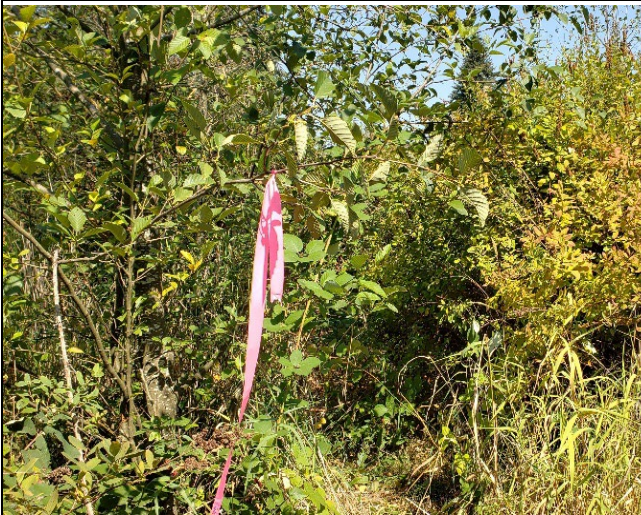
**Table 3. Wetland A Summary**

WETLAND A – INFORMATION SUMMARY		
Location:	Wetland A is located on the northeastern portion of subject property, extending offsite to the east.

Local Jurisdiction	Mill Creek
	WRIA	8 – Cedar/Sammamish
	WSDOE Rating (Hruby, 2014)	IV
	Mill Creek Rating	IV
	Mill Creek Buffer Width	50
	Wetland Size	3,140 SF onsite
	Cowardin Classification	PSSB
	HGM Classification	Depressional
	Wetland Data Sheet(s)	DP-5
	Upland Data Sheet (s)	DP-4
Boundary Flag color	Orange	
Dominant Vegetation	Wetland vegetation is dominated by redosier dogwood and hardhack.	
Soils	Hydric soil indicator F3 (Depleted Matrix) was observed.	
Hydrology	Hydrology for Wetland A is provided by a seasonally high groundwater table, direct precipitation, and surface sheet flow from adjacent uplands.	
Rationale for Delineation	Wetland boundaries were determined by topographic drop and a transition to a hydrophytic plant community.	
Rationale for Local Rating	Local rating is based upon WSDOE’s current rating system per MCMC 18.06.910.C.

Wetland Functions Summary		
Water Quality	Wetland A has a moderate potential to improve water quality functions with the minimal presence of persistent ungrazed plants that retain sediments and pollutants and the proximity to land uses that generate excess pollutants. Wetland A’s score for Water Quality Functions using the 2014 method is moderate (5).	
Hydrologic	Wetland A provides low hydrologic function due to the presence of a permanently flowing outlet and lack of seasonal ponding. Wetland A’s score for Hydrologic Functions using the 2014 method is moderate (5).	
Habitat	Wetland A has low habitat value due to the single Cowardin classification and interspersion as well as a single hydroperiod. Wetland A has limited species richness and lacks priority habitats. Wetland A’s score for Habitat Functions using the 2014 method is low (3).	
Buffer Condition	The buffer surrounding Wetland A is degraded due to the adjacent roadway (132 <sup>nd</sup> Street Southeast) and presence of non-native invasive species including Himalayan blackberry and reed canarygrass.

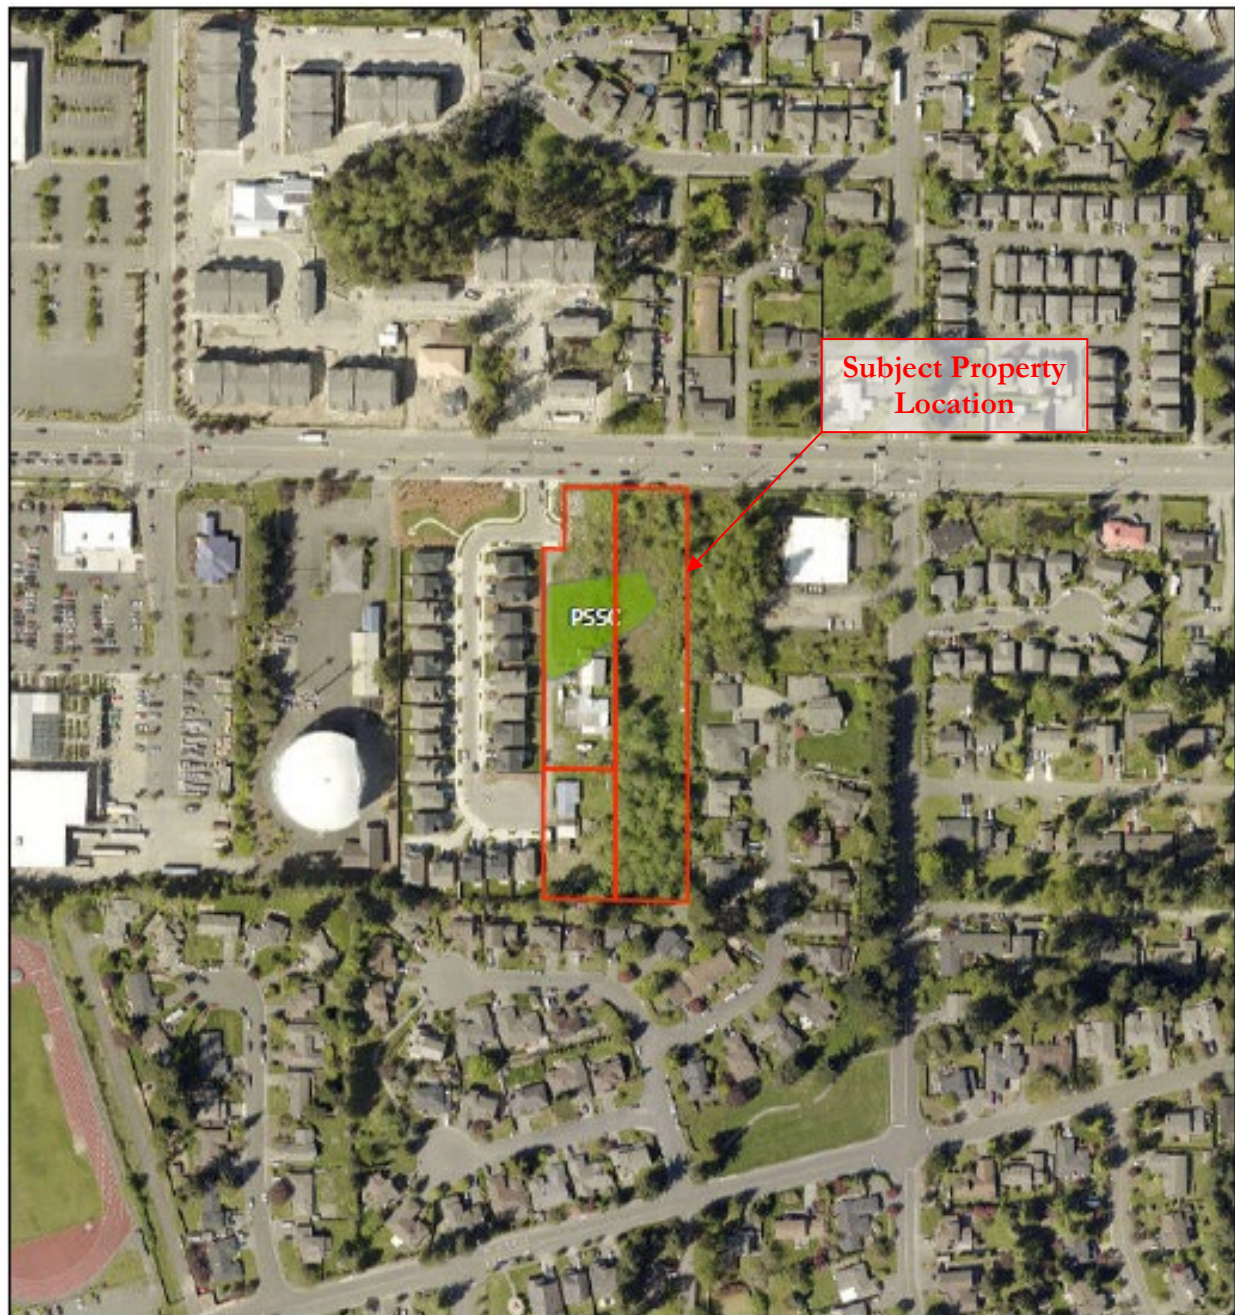
## Appendix B1. USFWS NWI Map

This appendix includes a USFWS NWI map (B1); Snohomish County Critical Areas inventory (B2); USGS Contours map (B3); NRCS soil survey map (B4); DNR Stream Typing map (B5); WDFW SalmonScape map (B6); WDFW PHS map (B7); and a FEMA Flood Hazard Areas Map (B8).

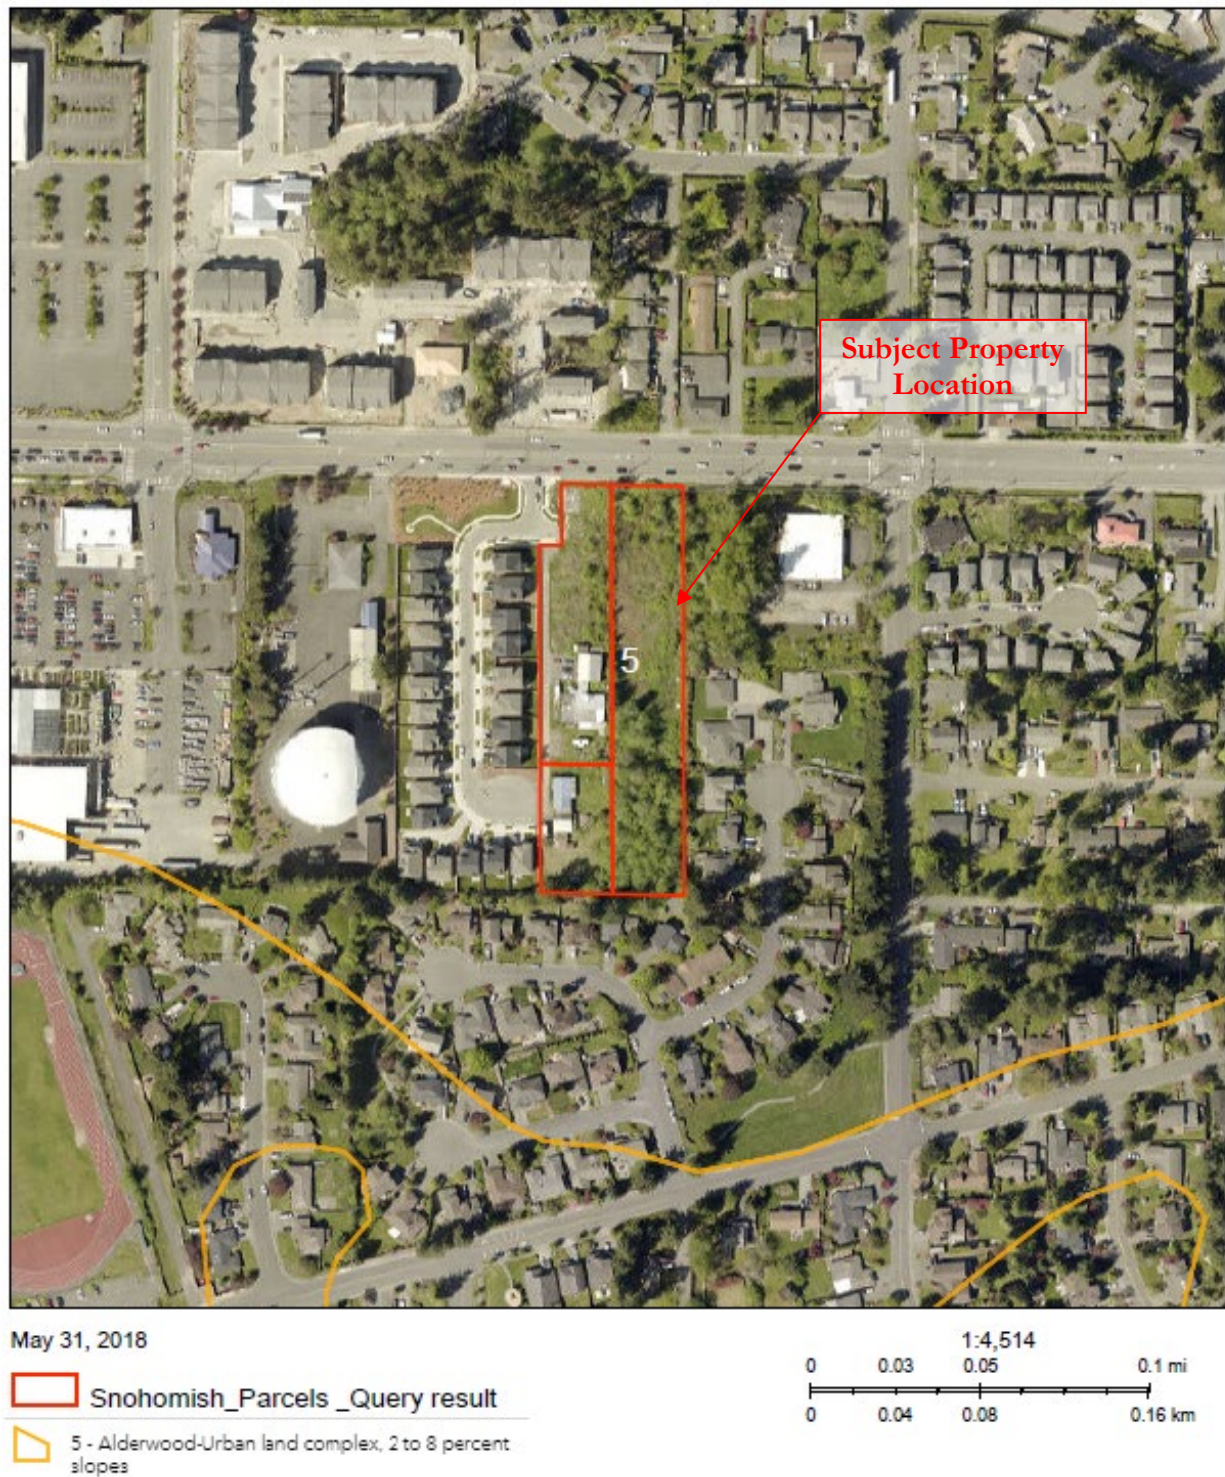
## Appendix B4. NRCS Soil Survey Map

The NRCS soil survey of Snohomish County identified one soil series on the subject property: Alderwood urban land complex, 2 to 8 percent slopes (5). A soil map is provided in Appendix B4. Below is a description of the soil profiles:

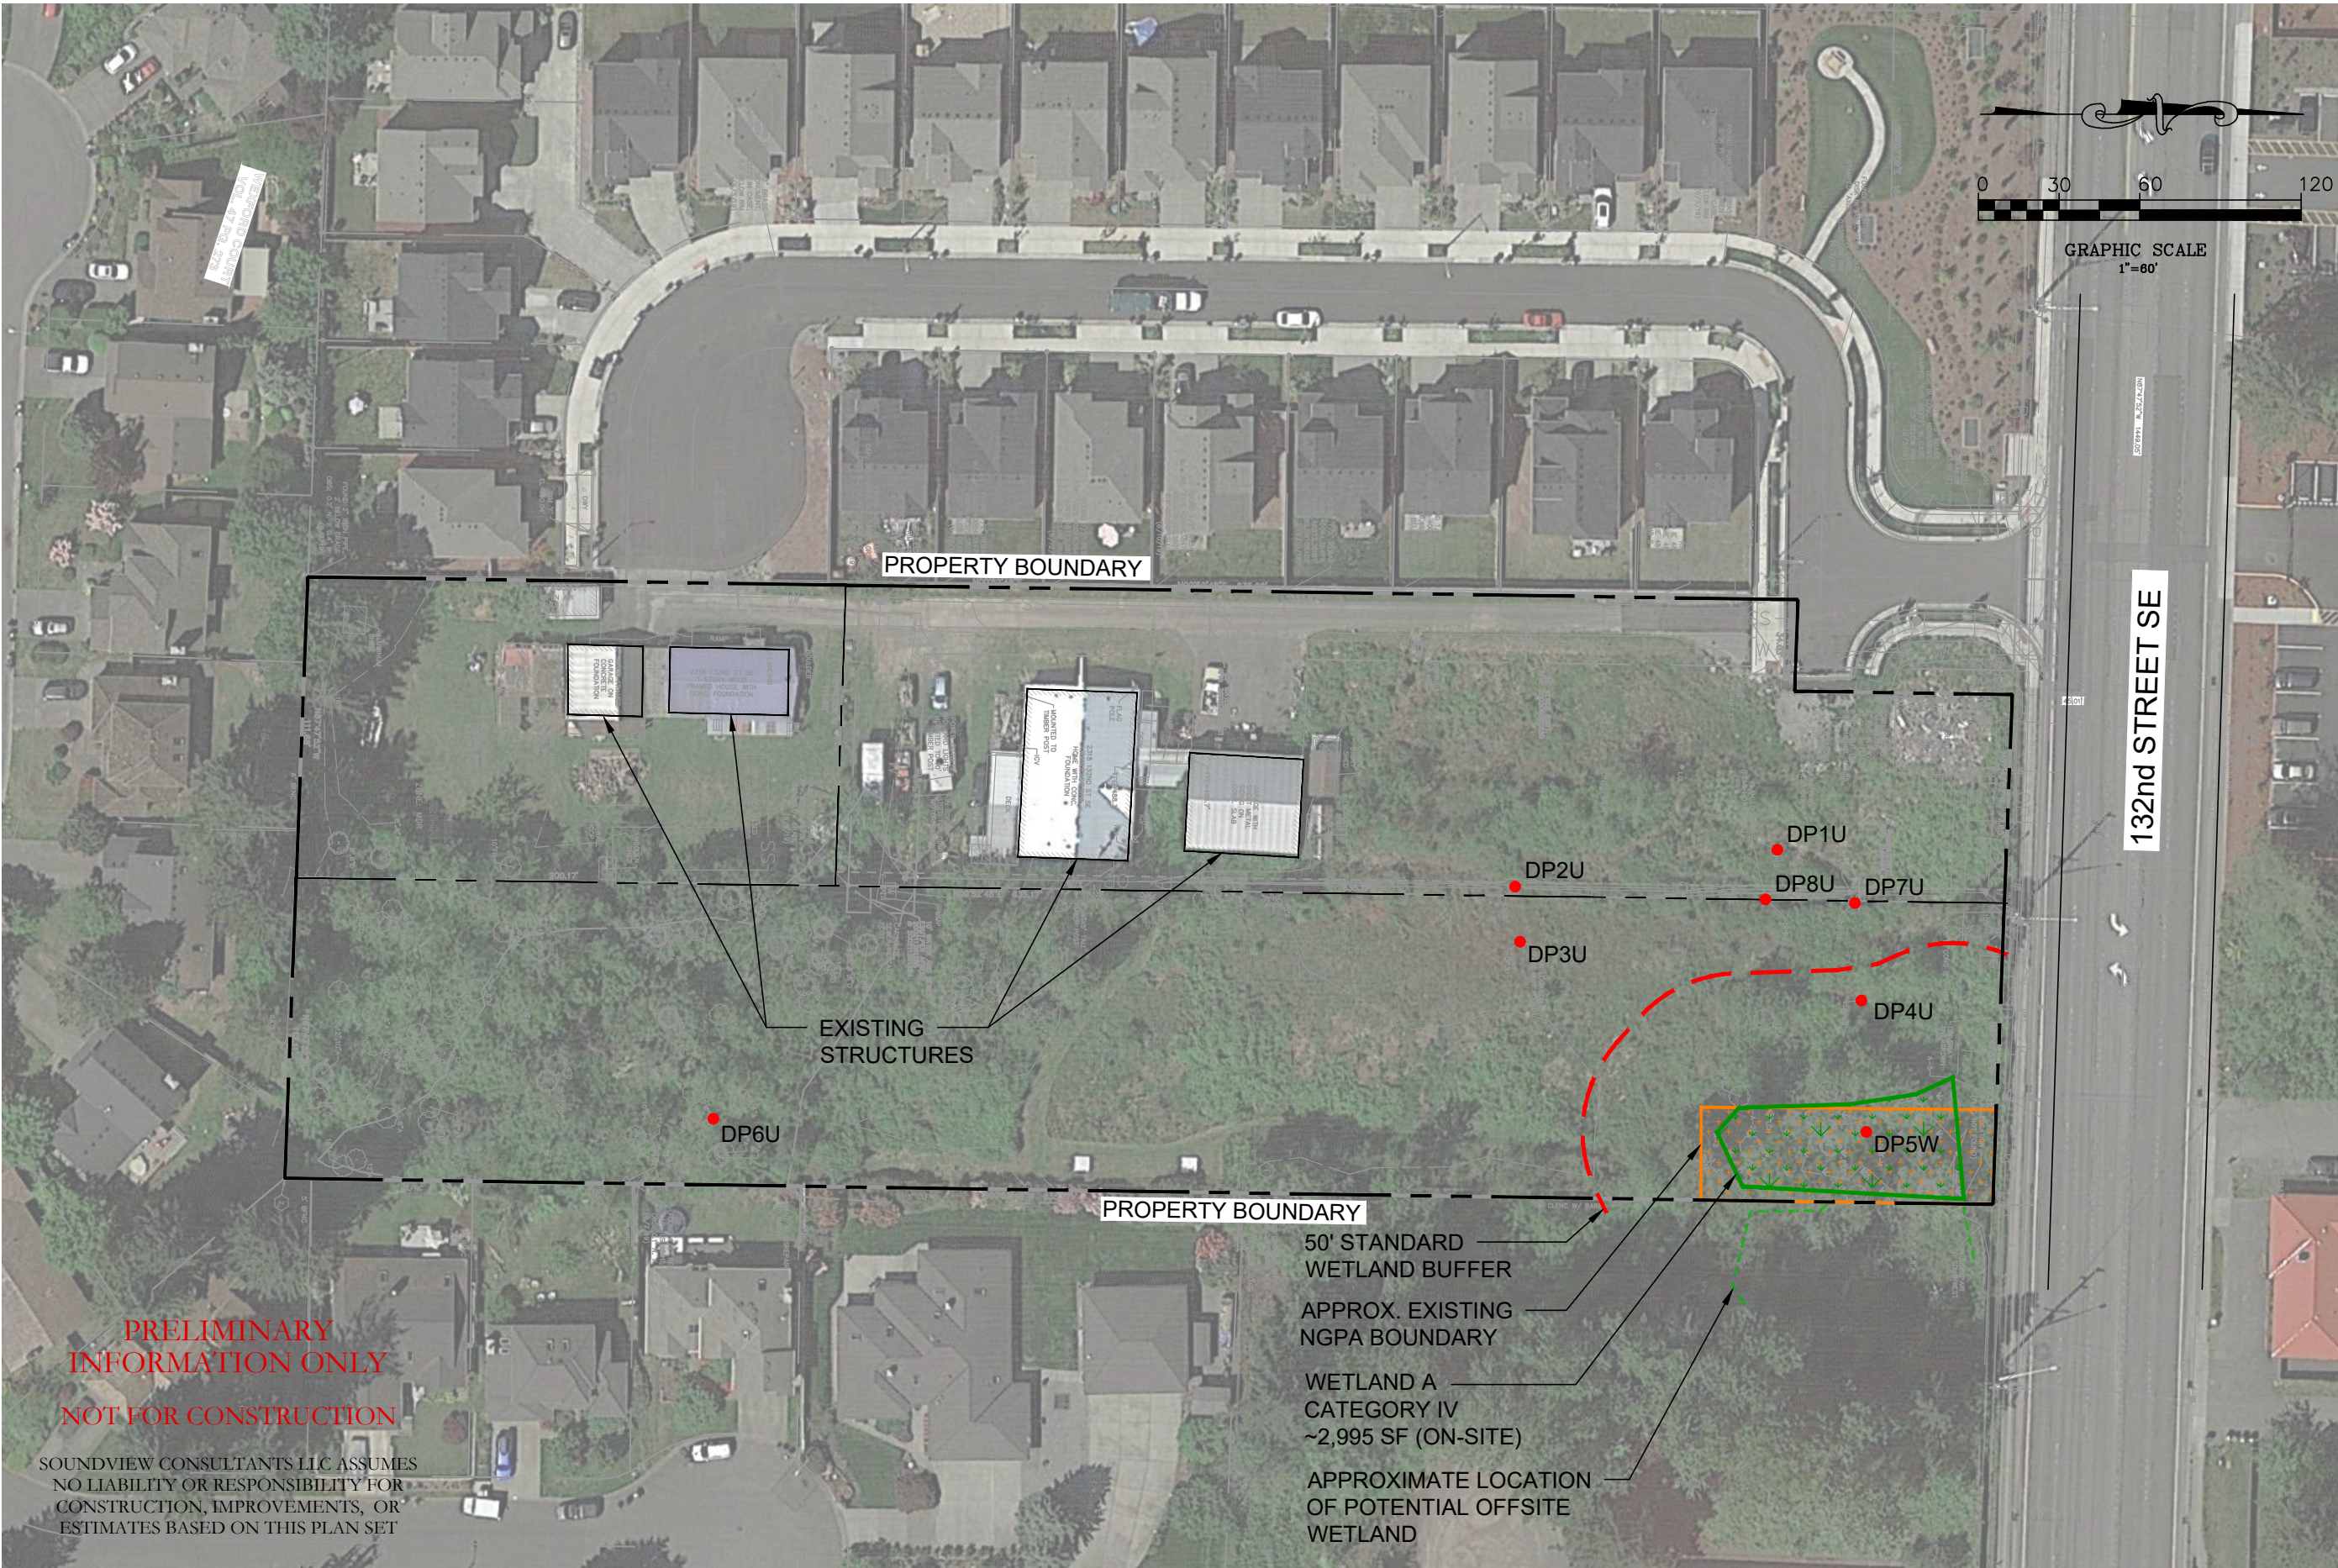
CRESTVIEW II - EXISTING CONDITIONS with AERIAL PHOTO

In 1997, Snohomish County (County) approved a critical areas site plan (CASP) for a grading violation with the previous owner of the subject property, which identifies a Native Growth Protection Area (NGPA) on the northeast portion of the site in the general area of a potential wetland (Snohomish County, 1997b) (Appendix I). SVC also obtained a copy of a Critical Areas Study (CAS) and Best Management Practices Mitigation from the County; the study describes two wetlands that reportedly previously existed in the north and east-central portions of the subject property (Snohomish County, 1997a) (Appendix I). The 1997 CAS does not appear to be based on an actual delineation (no wetland flags or data plots are indicated), and SVC is unable to determine the methodology on how the wetland areas in the CAS were determined. The CAS is greater than 20 years old and generally inconsistent with current site conditions. It is important to note that the 1997 study would have utilized outdated wetland delineation methods (Environmental Laboratory, 1987; WSDOE, 1997) which in many instances yielded positive soil indicators that would not meet technical hydric soil criteria under current wetland delineation methodology (USACE, 2010). Nonetheless, these areas were designated as former “Category 3 Wetlands” under the past Snohomish County Code. As mitigation for the grading violation, a 3,850-square-foot NGPA was established in the northeastern corner of the subject property. Grading within the potential wetland area was not required to be restored; the establishment of the NGPA appears to be the only mitigation requirement for the violation. The prior-established NGPA is mapped on the Existing Conditions Map in Appendix D.

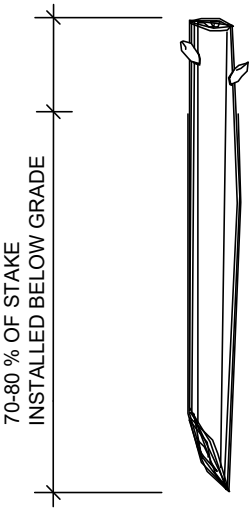
1. LIVE STAKES TO BE 1 TO 2 INCH DIAMETER 24 TO 32 INCHES LENGTH.
2. USE 1/2 INCH DIAMETER REBAR OR ROCK BAR TO MAKE PILOT HOLE.
3. INSTALL LIVE STAKES TAPER END DOWN WITH BUDS POINTED UP.
4. MINIMUM TWO BUDS ABOVE GRADE.
5. SET LIVE STAKES WITH DEAD-BLOW HAMMER.
6. WATER IMMEDIATELY AFTER INSTALLATION.

**STORAGE OF LIVE STAKES**  
ALL WOODY PLANT CUTTINGS COLLECTED  
MORE THAN 12 HR PRIOR TO INSTALLATION,  
MUST BE CAREFULLY BOUND, SECURED,  
AND STORED OUT OF DIRECT SUNLIGHT  
AND SUBMERGED IN CLEAN FRESH WATER  
FOR A PERIOD OF UP TO TWO WEEKS.

OUTDOOR TEMPERATURES MUST BE LESS  
THAN 50 DEGREES F AND TEMPERATURE  
INDOORS AND IN STORAGE CONTAINERS  
MUST BE BETWEEN 34 AND 50 DEGREES F.

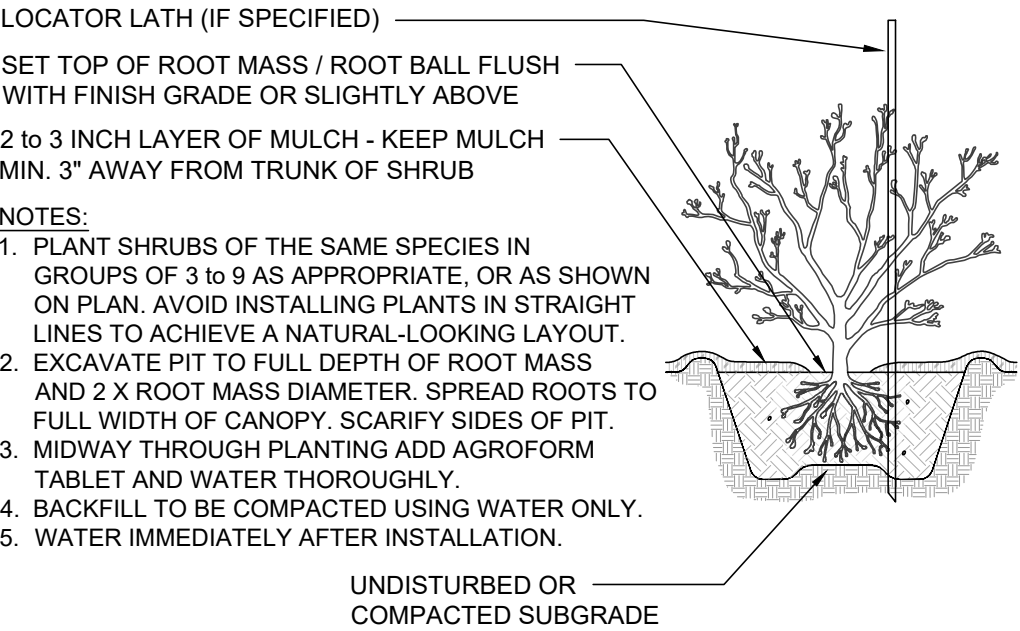
SHRUB PLANTING DETAIL

1. PLANT SHRUBS OF THE SAME SPECIES IN GROUPS OF 3 to 9 AS APPROPRIATE, OR AS SHOWN ON PLAN. AVOID INSTALLING PLANTS IN STRAIGHT LINES TO ACHIEVE A NATURAL-LOOKING LAYOUT.
2. EXCAVATE PIT TO FULL DEPTH OF ROOT MASS AND 2 X ROOT MASS DIAMETER. SPREAD ROOTS TO FULL WIDTH OF CANOPY. SCARIFY SIDES OF PIT.
3. MIDWAY THROUGH PLANTING ADD AGROFORM TABLET AND WATER THOROUGHLY.
4. BACKFILL TO BE COMPACTED USING WATER ONLY.
5. WATER IMMEDIATELY AFTER INSTALLATION.

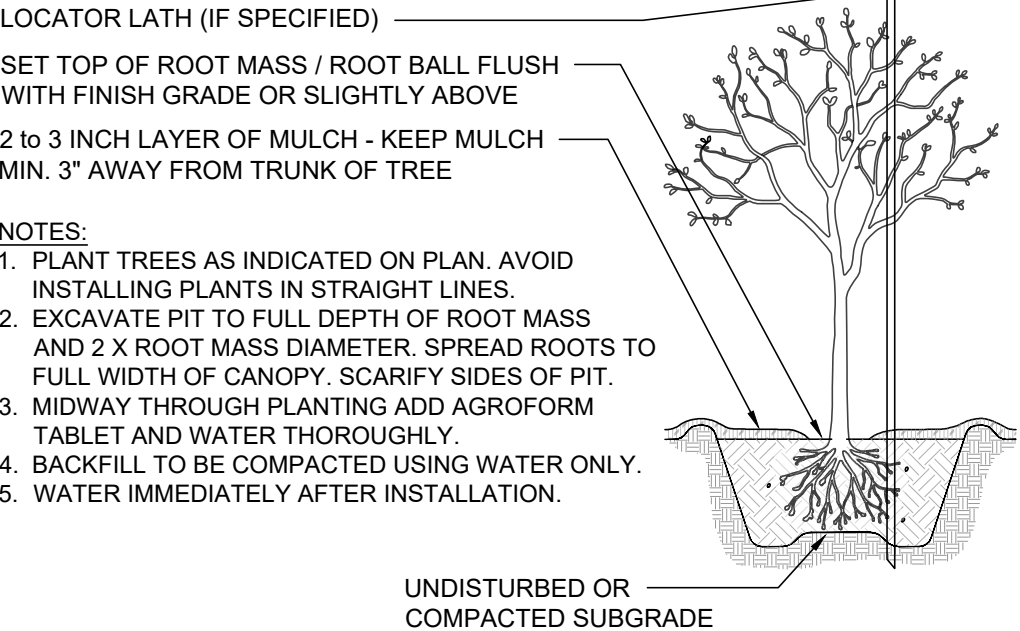
TREE PLANTING DETAIL

1. PLANT TREES AS INDICATED ON PLAN. AVOID INSTALLING PLANTS IN STRAIGHT LINES.
2. EXCAVATE PIT TO FULL DEPTH OF ROOT MASS AND 2 X ROOT MASS DIAMETER. SPREAD ROOTS TO FULL WIDTH OF CANOPY. SCARIFY SIDES OF PIT.
3. MIDWAY THROUGH PLANTING ADD AGROFORM TABLET AND WATER THOROUGHLY.
4. BACKFILL TO BE COMPACTED USING WATER ONLY.
5. WATER IMMEDIATELY AFTER INSTALLATION.

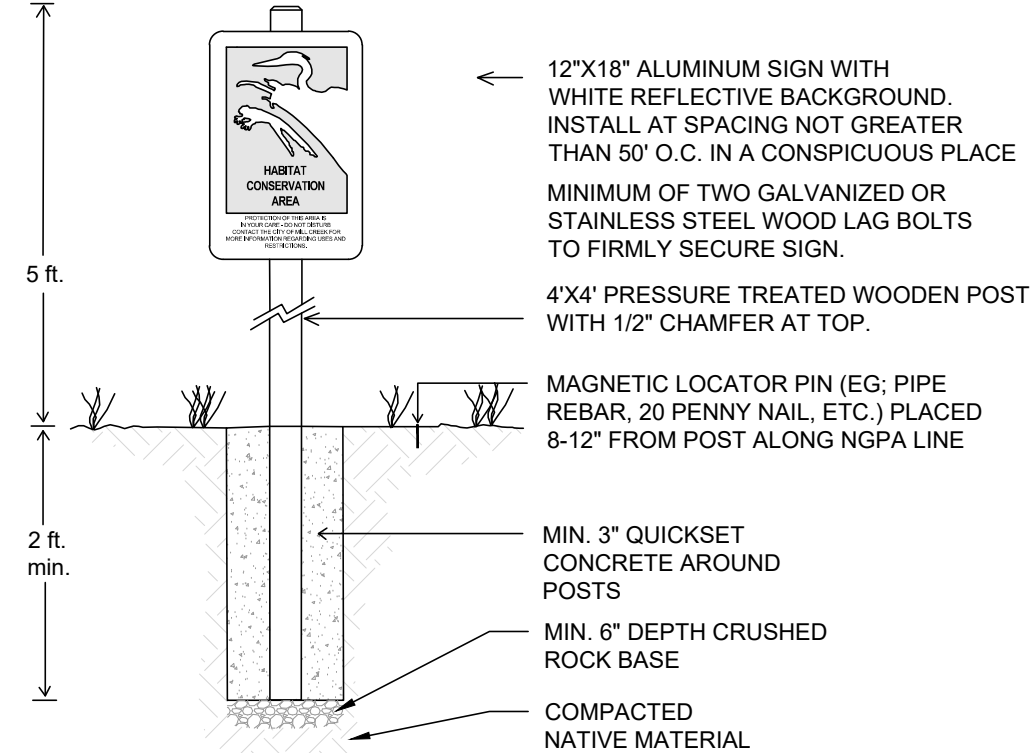
CRITICAL AREA BOUNDARY SIGN DETAIL

1. CRITICAL AREA BOUNDARY SIGNS SHALL BE PLACED NO GREATER THAN 50 FEET APART AROUND THE PERIMETER OF THE WETLAND BUFFERS RESTORATION AREA, UNLESS OTHERWISE APPROVED BY THE PROJECT BIOLOGIST.
2. SIGN PLACEMENT SHALL BE SUBJECT TO THE APPROVAL OF CITY STAFF. ALTERNATIVE SIGN DESIGNS MAY BE SUBMITTED TO CITY STAFF FOR APPROVAL.
3. ALL SIGNS MUST BE SECURE AND PERMANENT.
