# **Drainage Report**

# The Farm at Mill Creek

March 8, 2019 Job No: 17-127

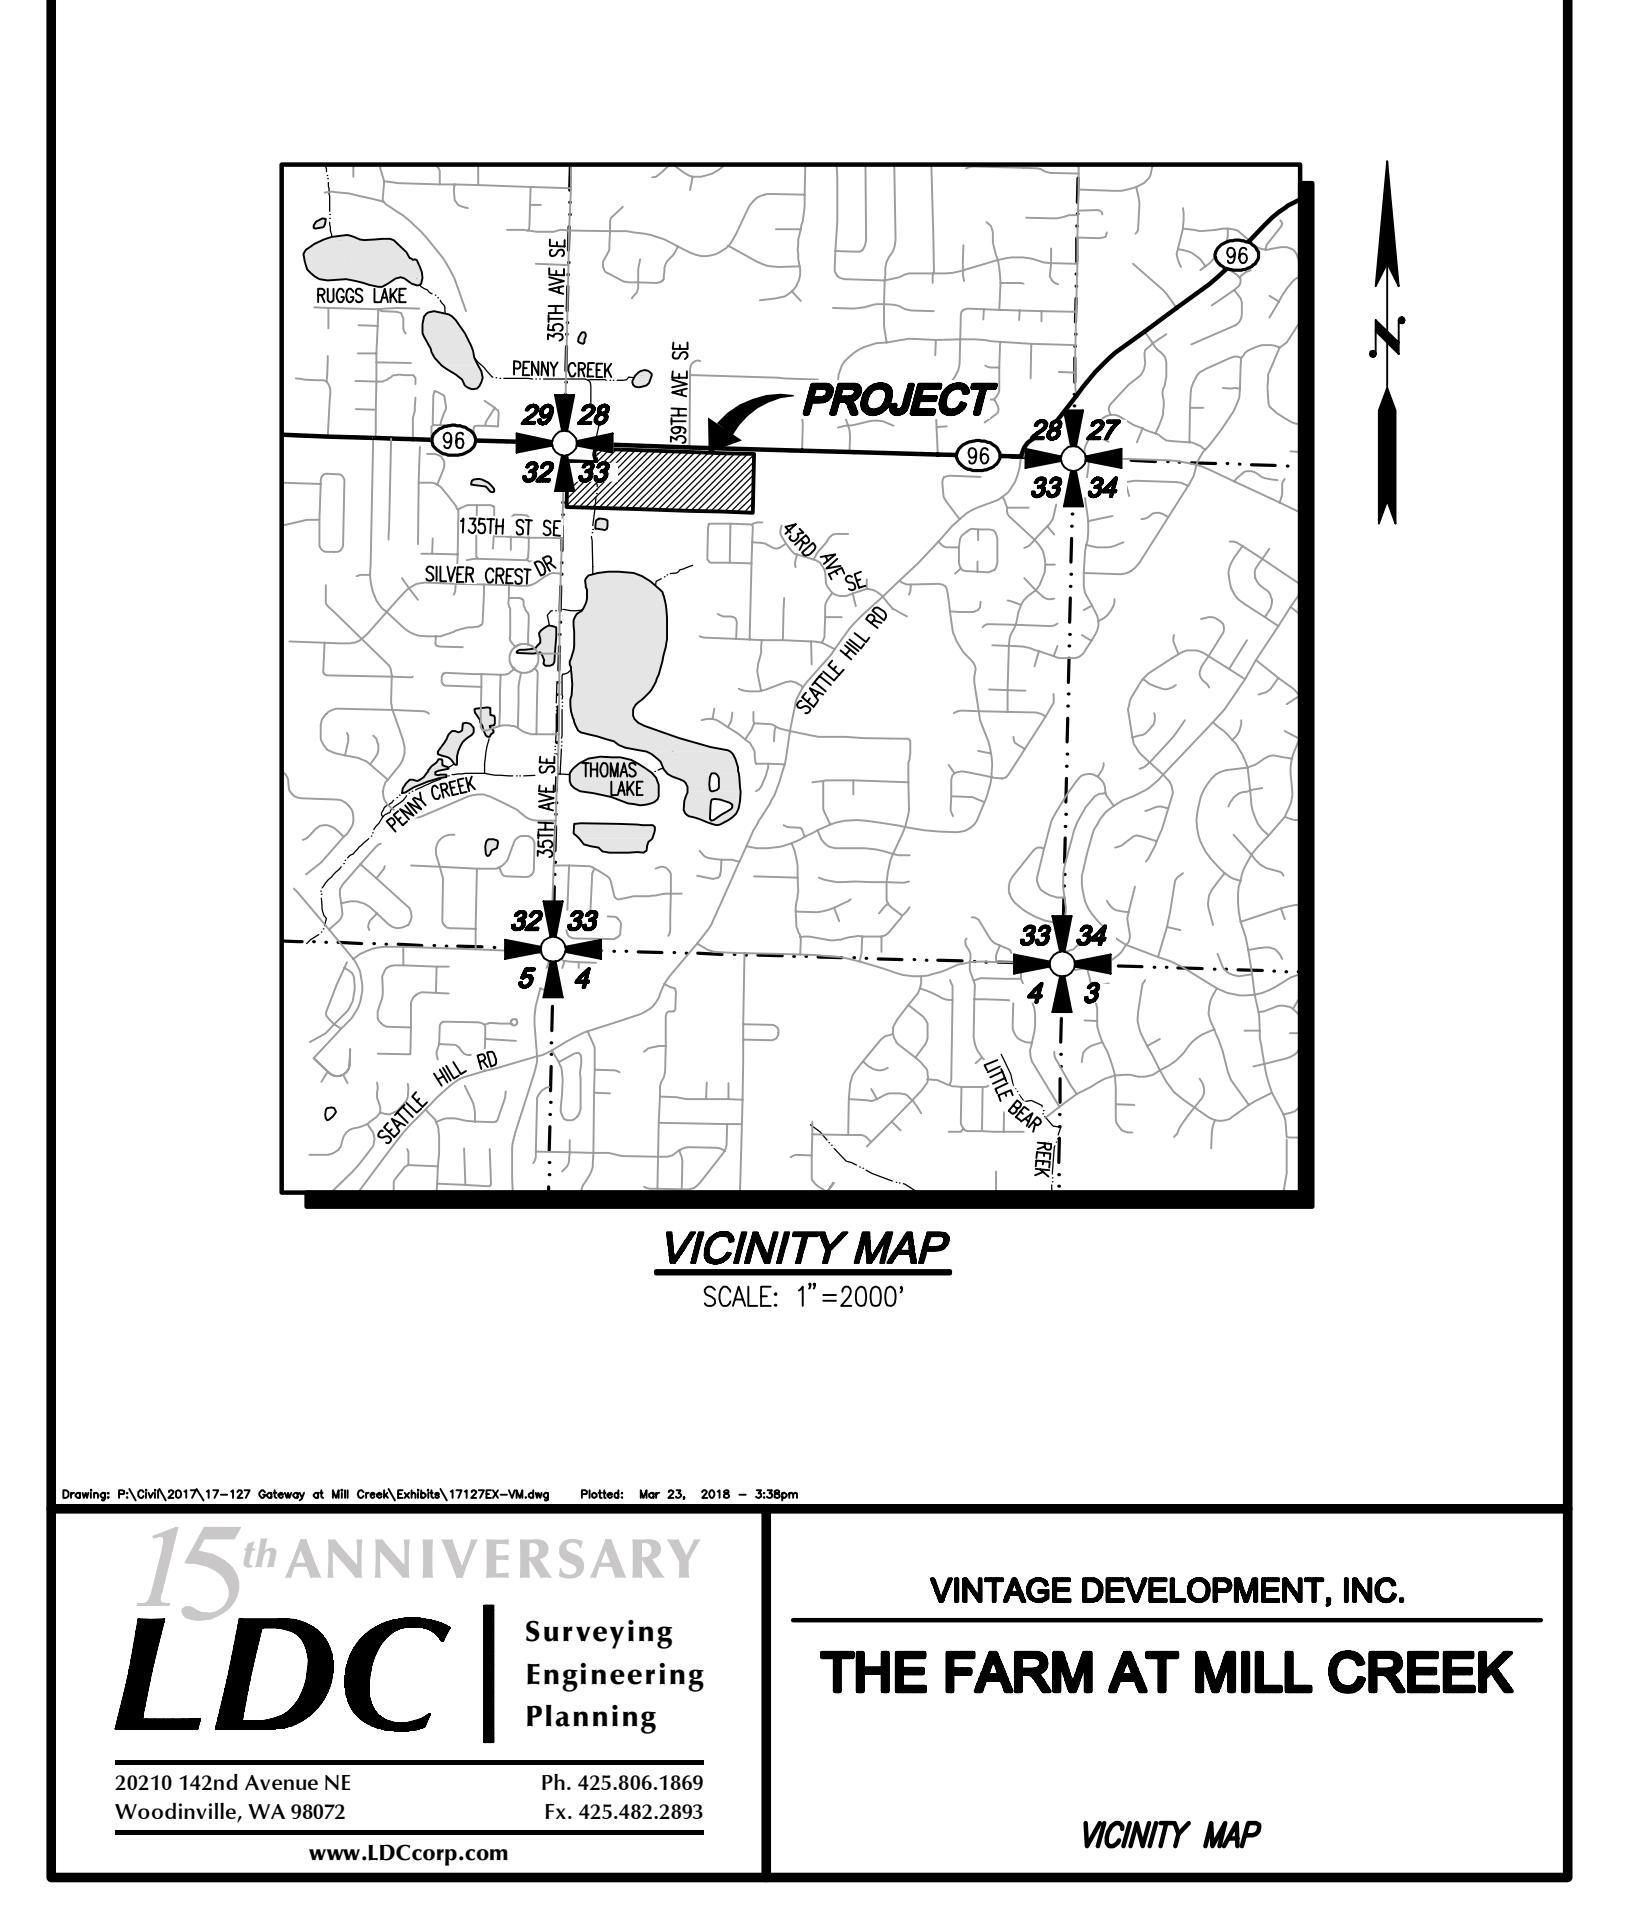
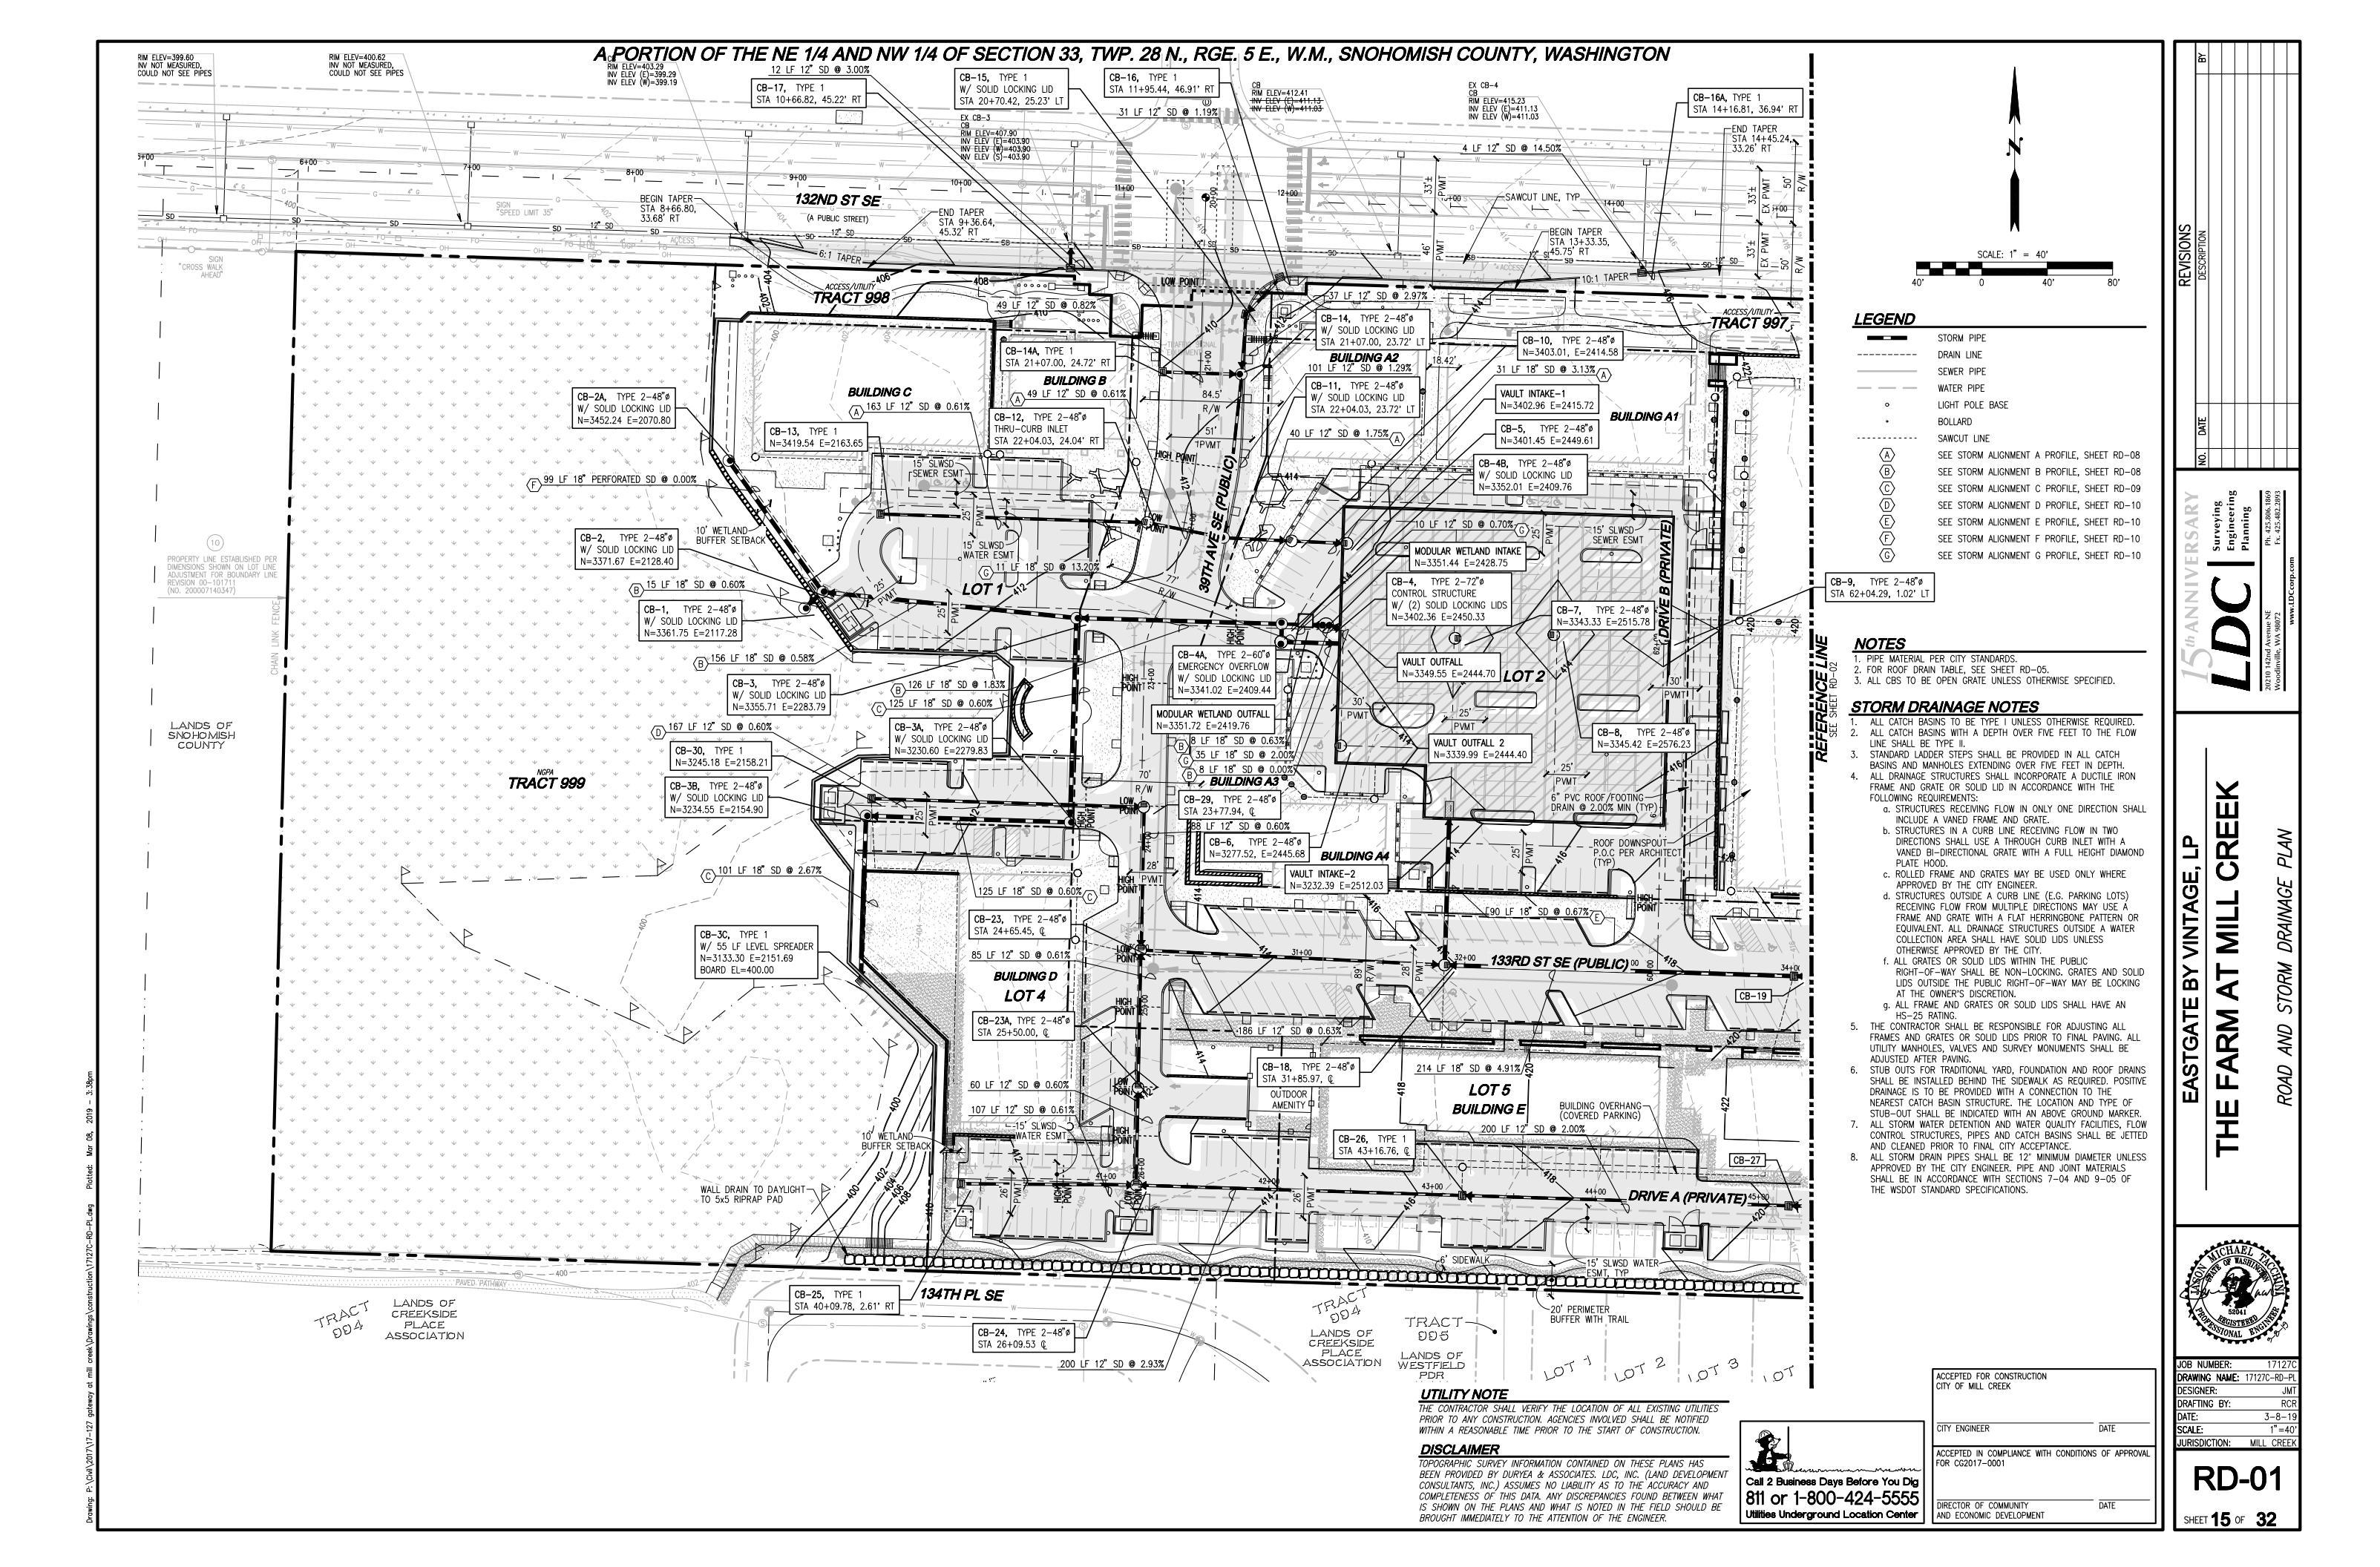
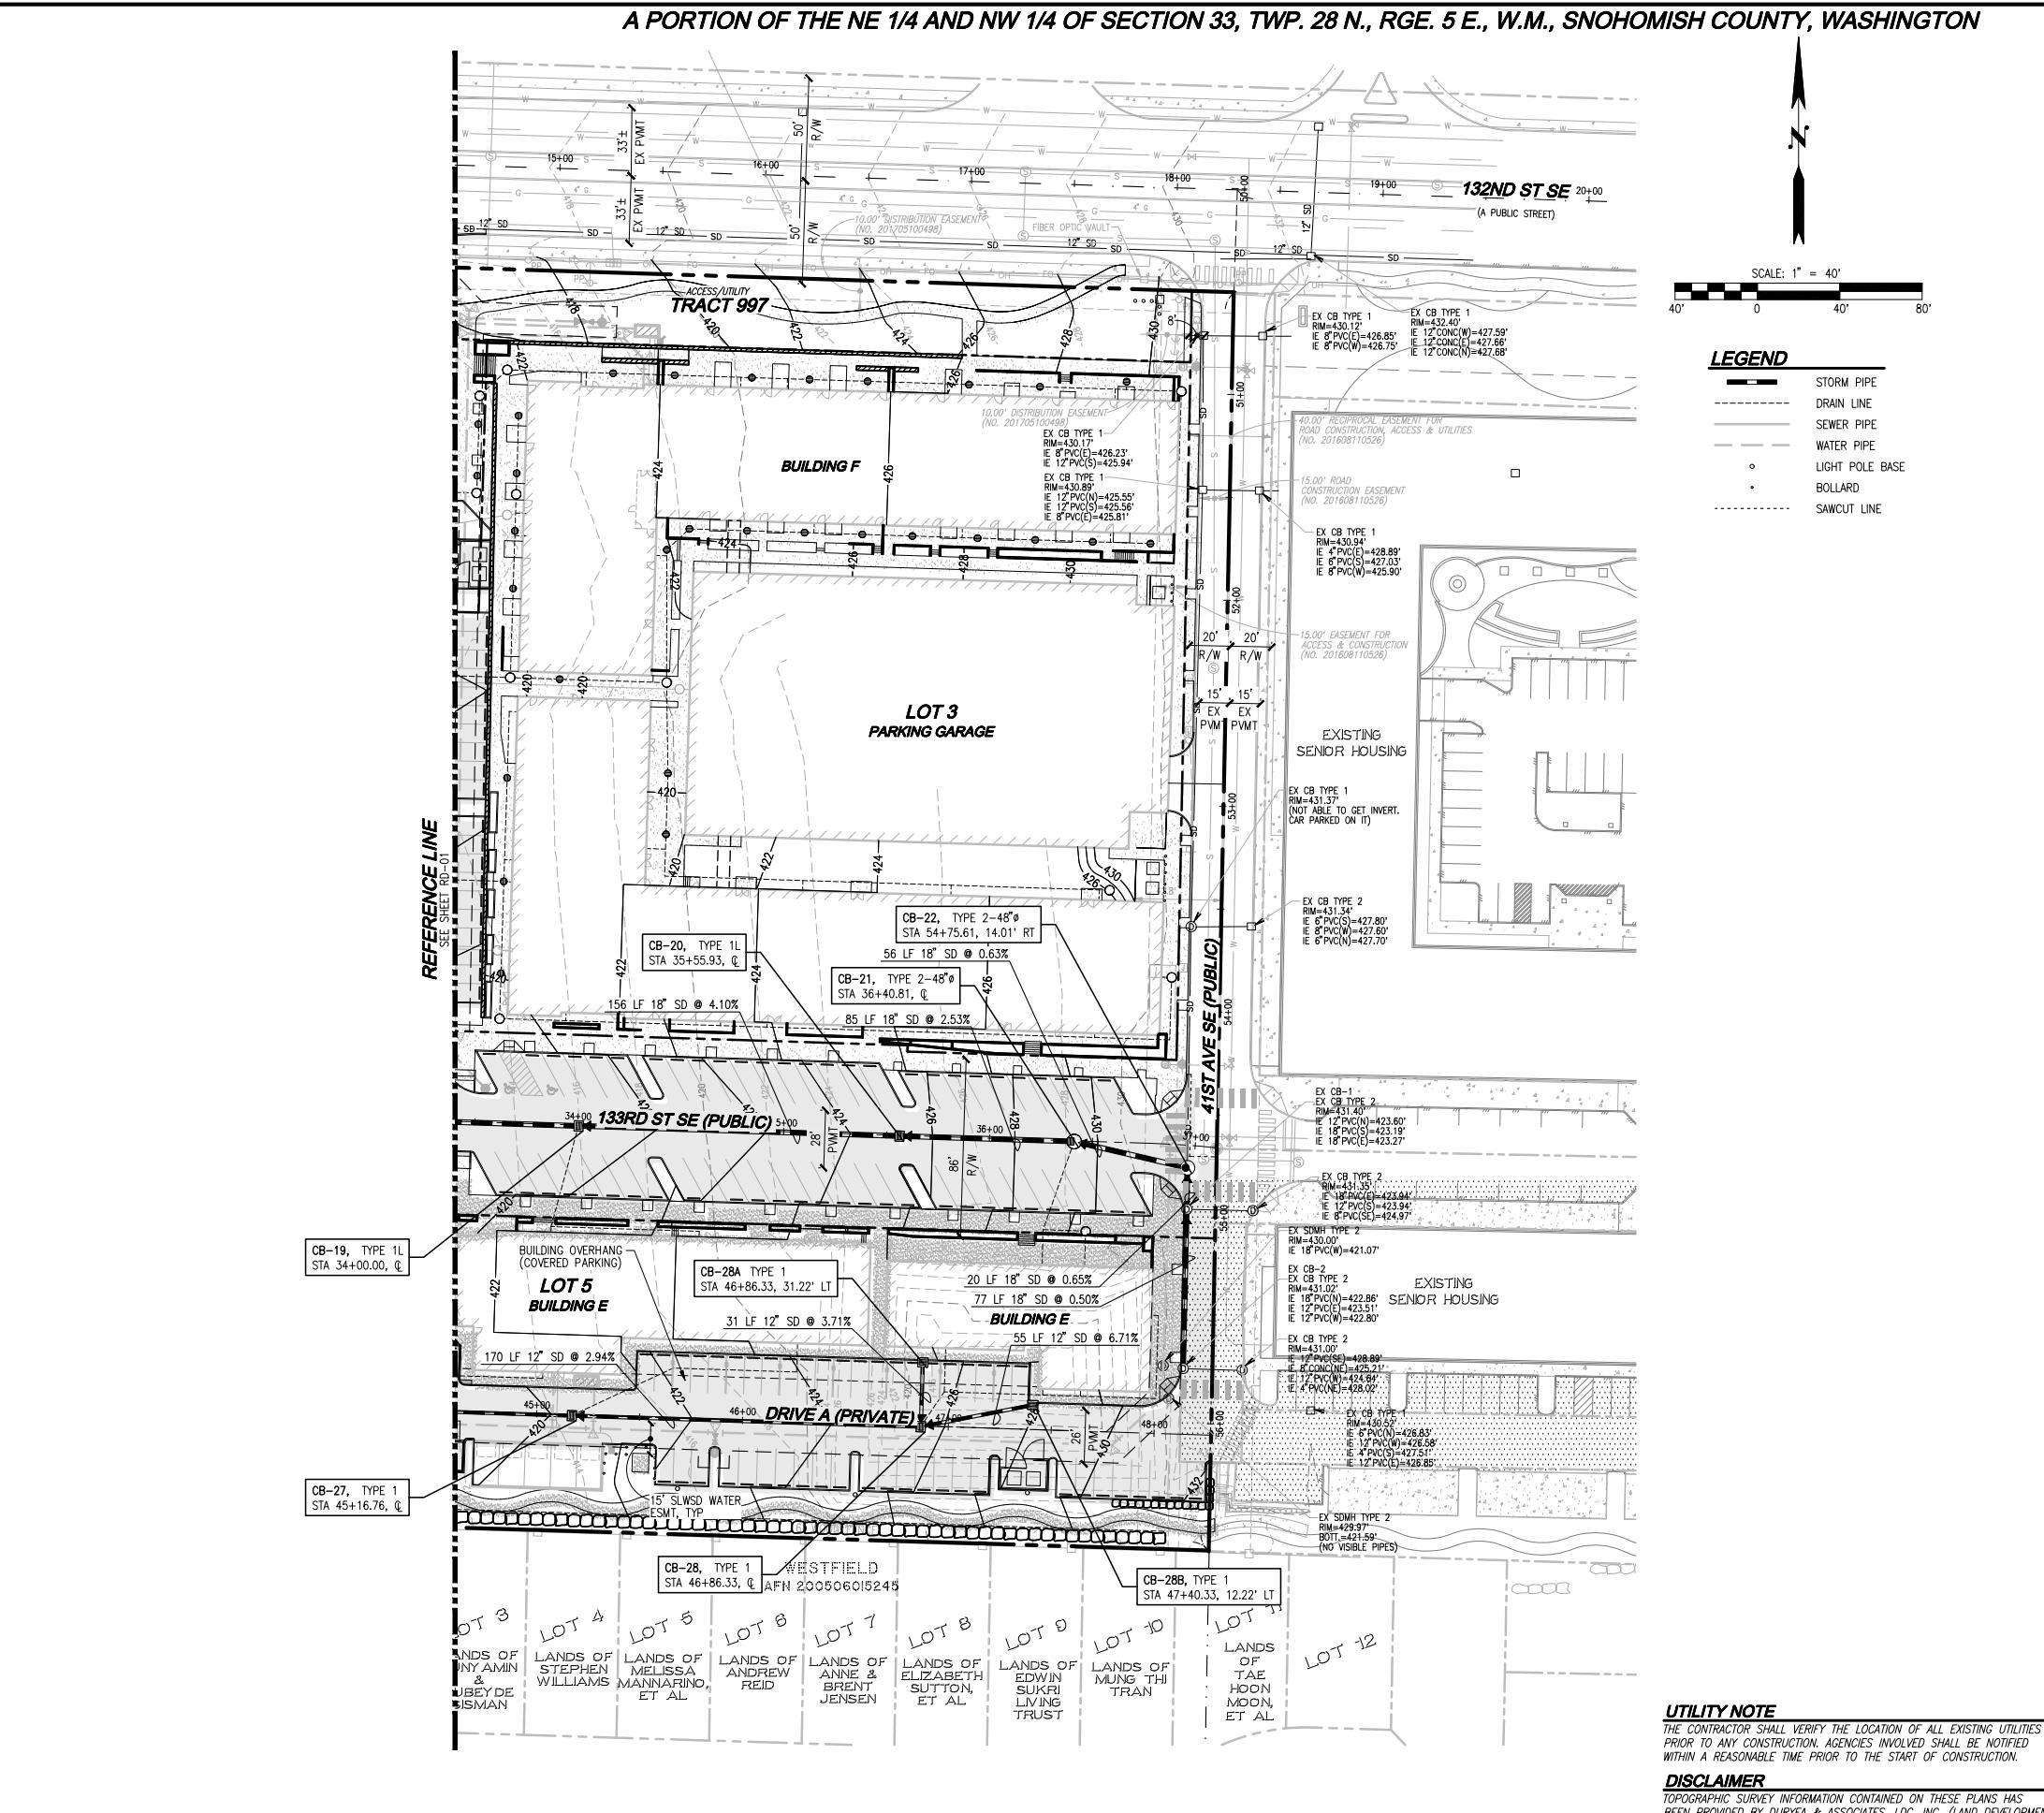
The proposed site will be a mixed use retail and commercial development. This commercial development will include retail spaces, driveways, parking lot for all the building, landscaping, and associated utilities. See sheet RD-01 and RD-02 in this section for the proposed site layout.

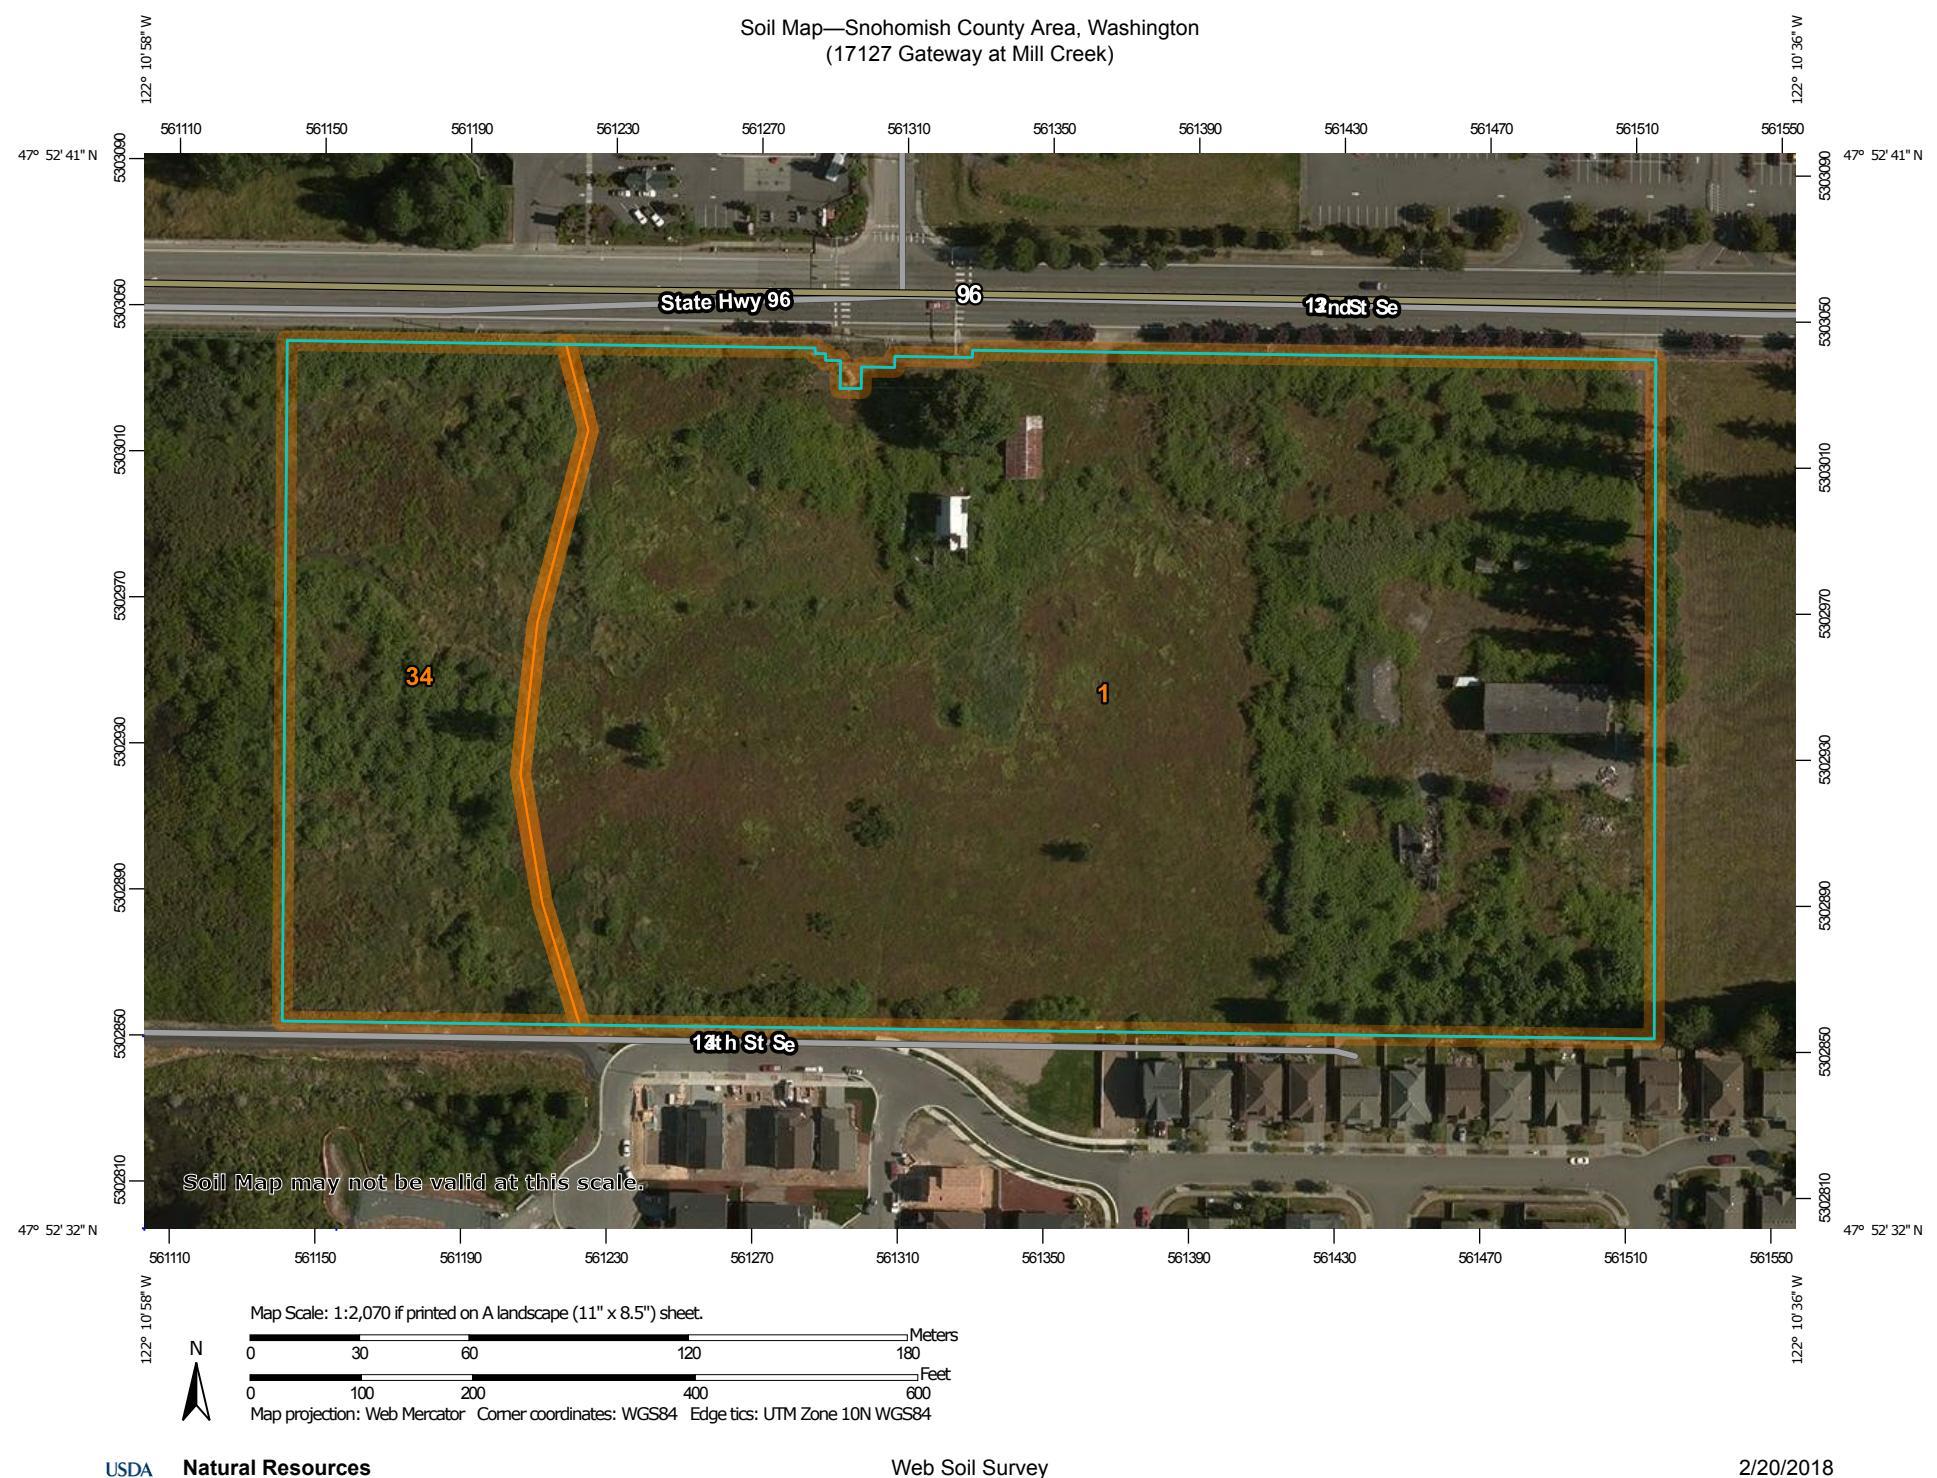
# SCS SOIL SURVEY MAPPING

According to the USDA web soil survey map, the proposed commercial development area of the site is underlain by Alderwood gravelly sandy loam. See Appendix 1-A for the attached USDA web soil survey map and soil description.

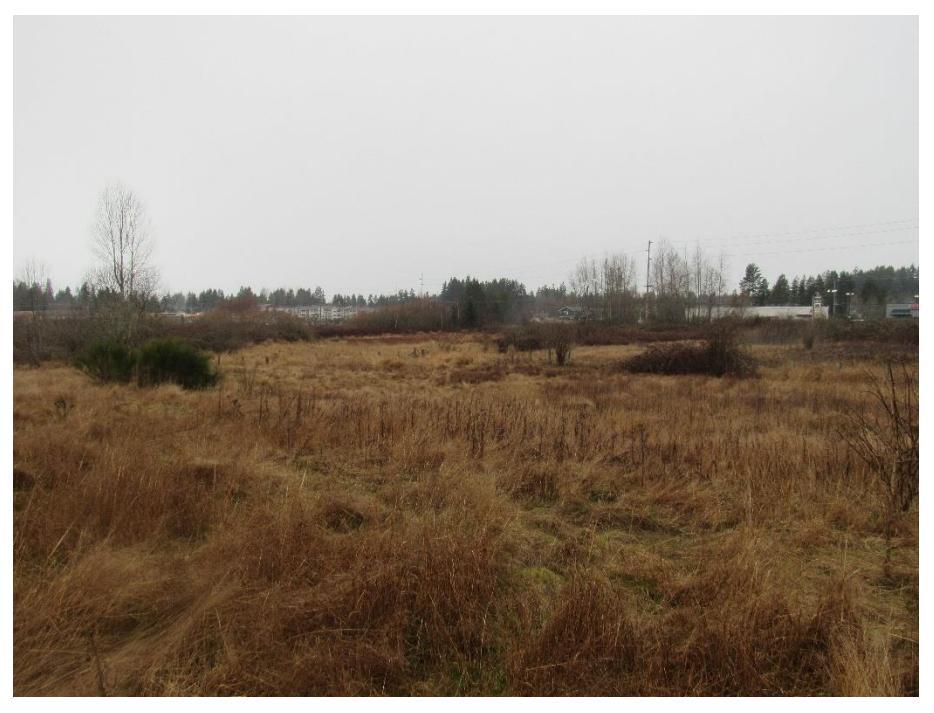
Image #1: Looking west on the subject property towards the NGPA and onsite wetland.

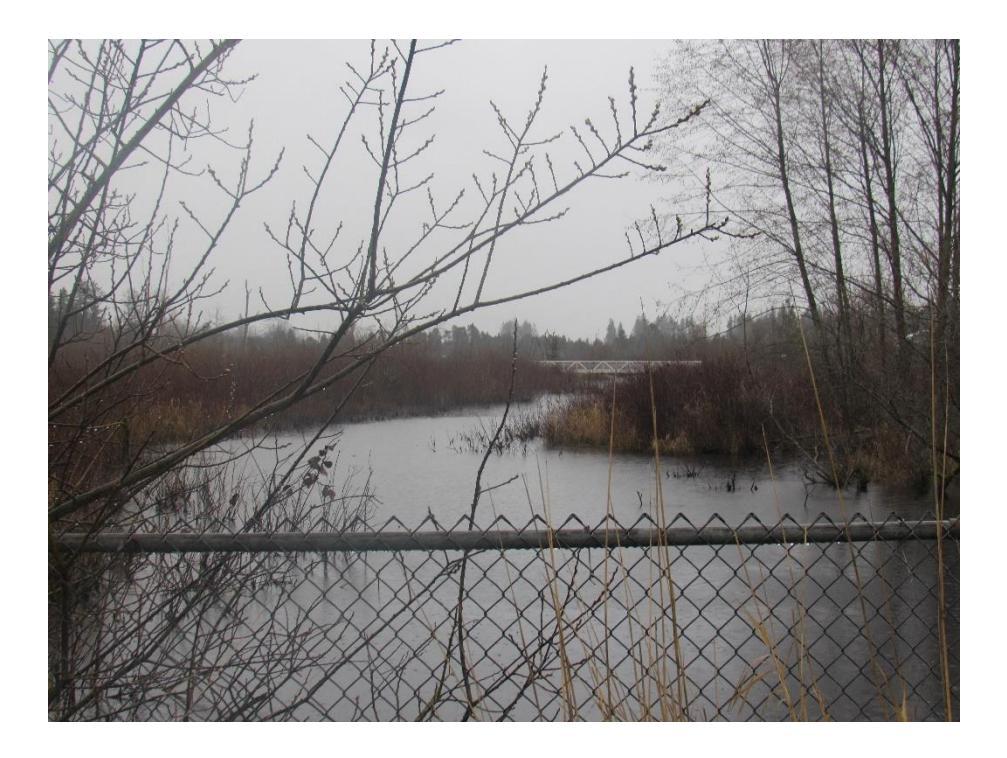
Image #2: Looking south on the south side of HWY 96 towards the NGPA.

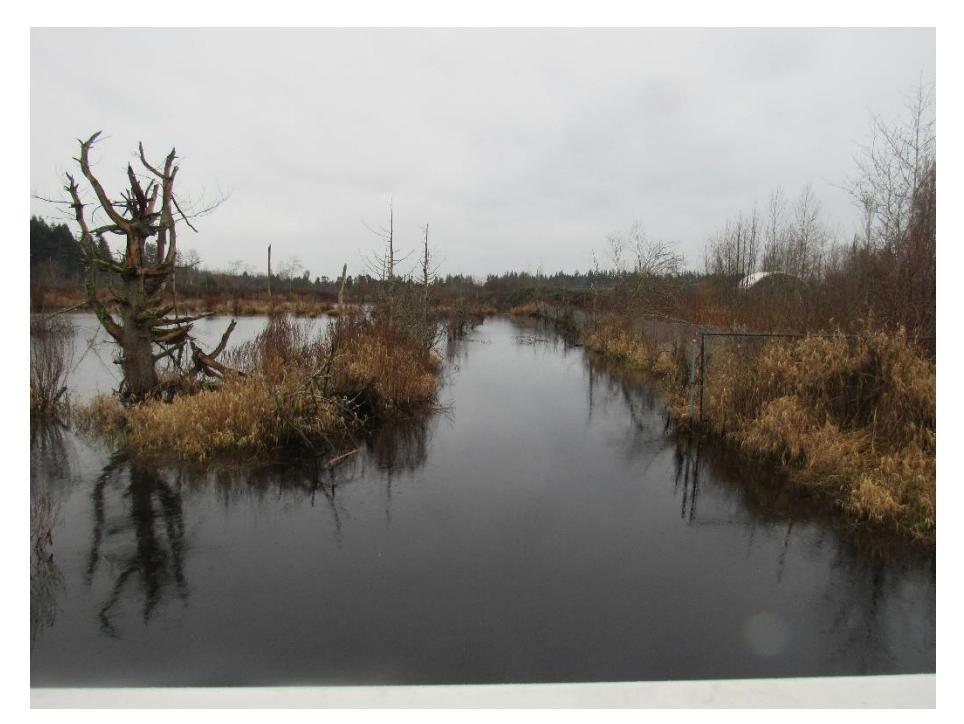
Image #3: Looking south at the adjoining wetland paralleling 35<sup>th</sup> AVE SE from the pedestrian walkway connecting 134<sup>th</sup> PL SE and 35<sup>th</sup> AVE SE.

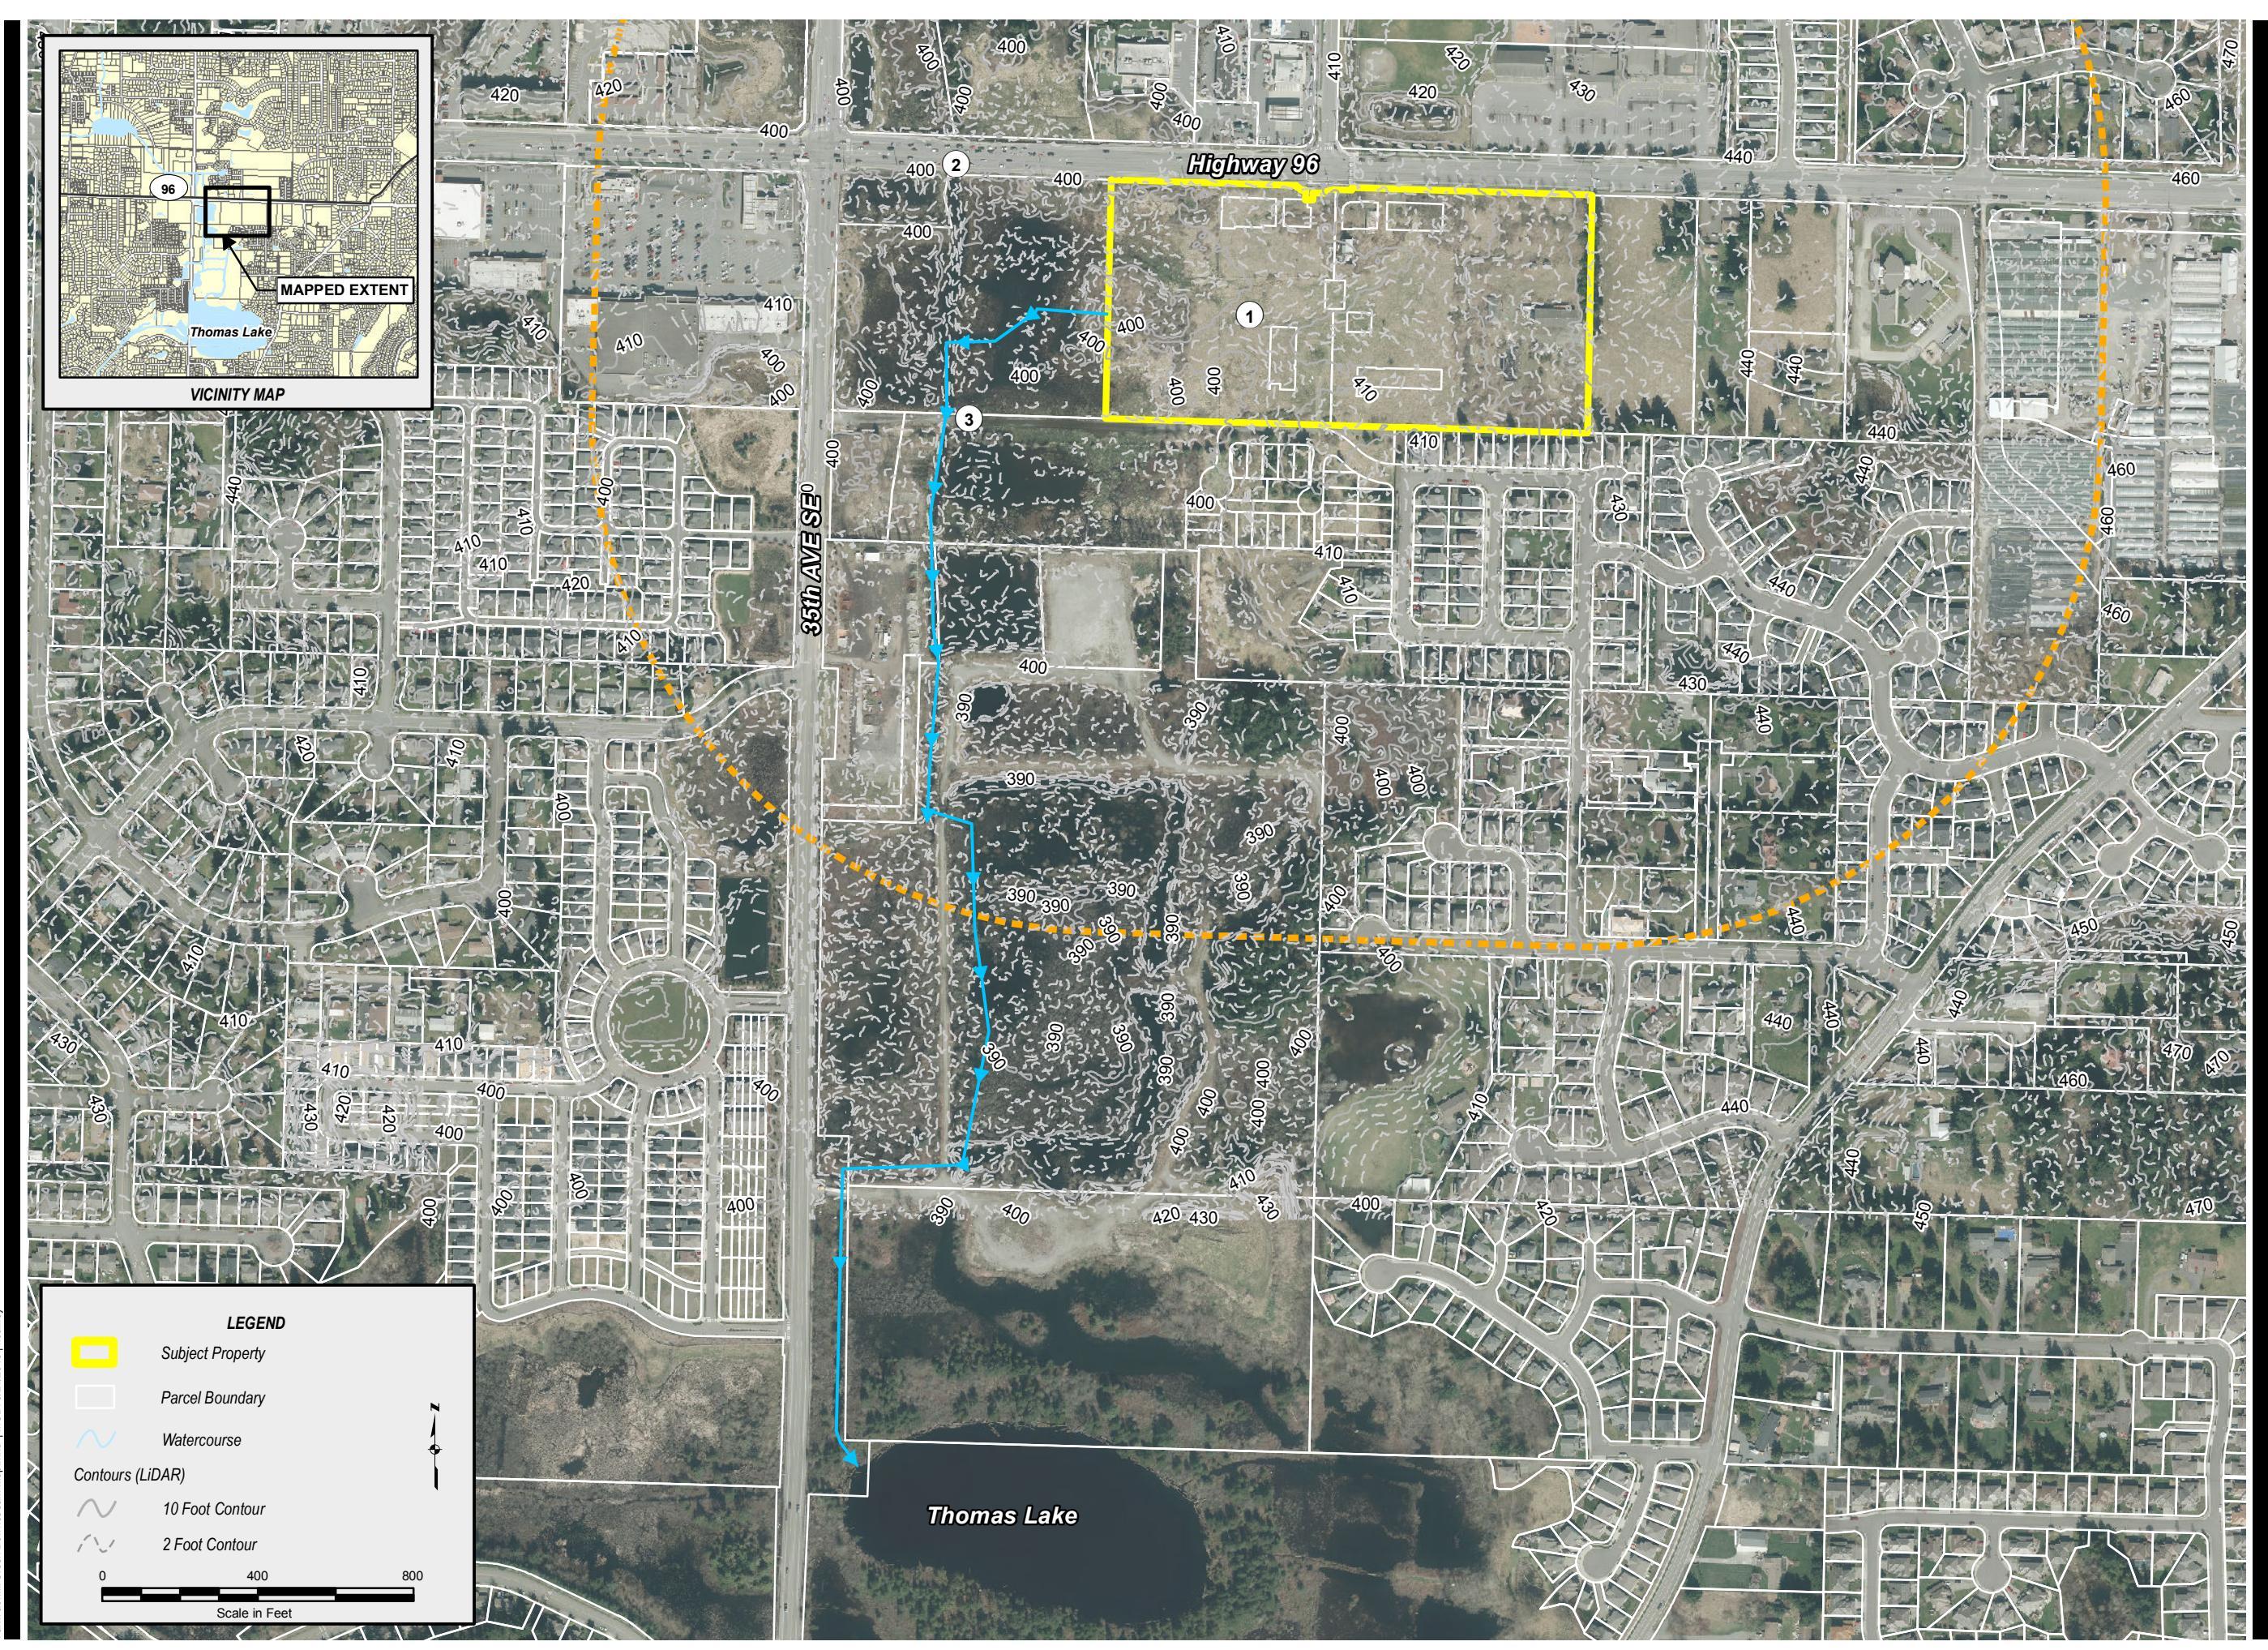
# DOWNSTREAM ANALYSIS MAP

Note: See Figure 5, Downstream Analysis Map, in Appendix 4-A for a detailed map of the downstream flow paths and visual depiction of photo locations

The onsite Basin currently sheet flows to the west to an existing NGPA and wetland. The flow then enters the Penny Creek and flows south eventually entering Thomas Lake. See the Downstream Analysis discussion in Section 4 for more detailed discussion. See Figure 5 in Appendix 4-A for visual representation of the downstream flow path.
