# **Drainage Report**

# The Farm at Mill Creek

March 8, 2019 Job No: 17-127

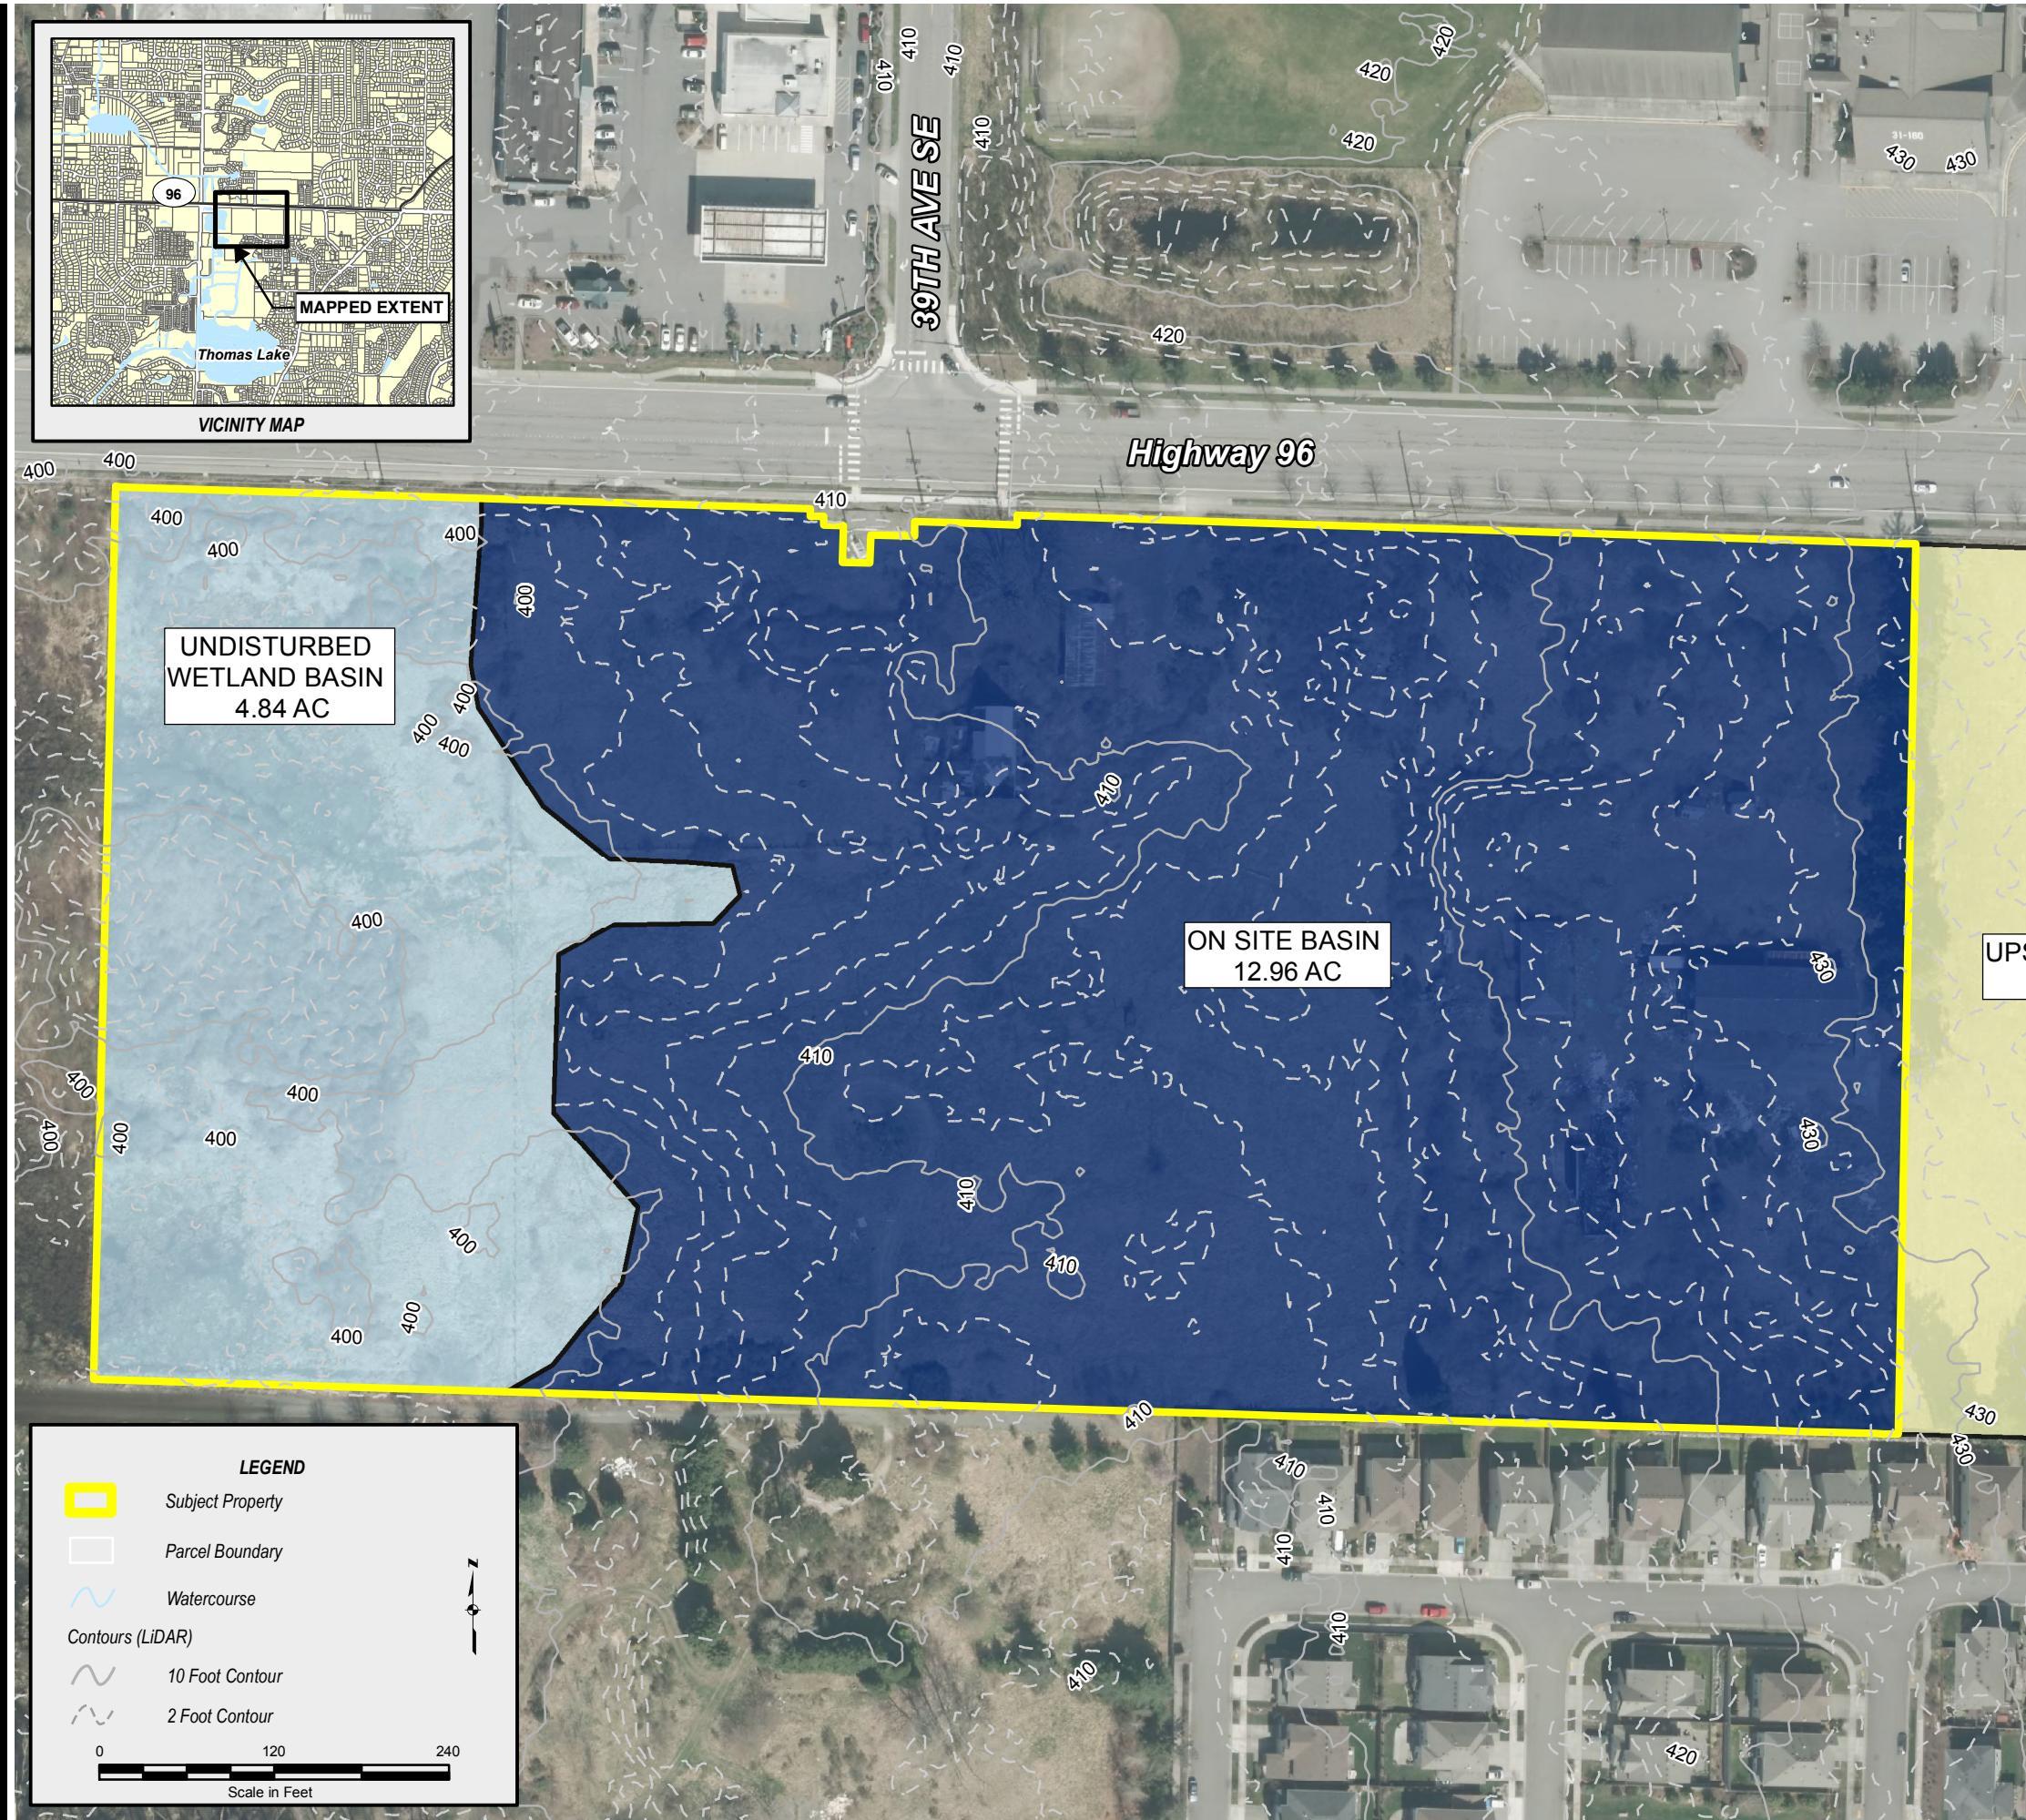
As discussed in the Project Overview (Section 1), The existing site contains an old warehouse, various outbuildings, the remains of a collapsed house, landscaped areas, forest and wetlands totaling 17.37 acres. Runoff in the pre-developed conditions flows from the eastern portion of the site to the western portion of the site containing a wetland (Wetland A) approximately 4.84 acres in size. See Figure 6.0 in this section for the Existing Condition Map.

Forested12.96 AcresUndisturbed Wetland/NGPA4.84 Acres

Existing drainage on the site flows from east to west towards the wetland. There are no areaspecific requirements for either of these watersheds/basins. See Figure 6 in Section 4 for visual representation of the existing basins.

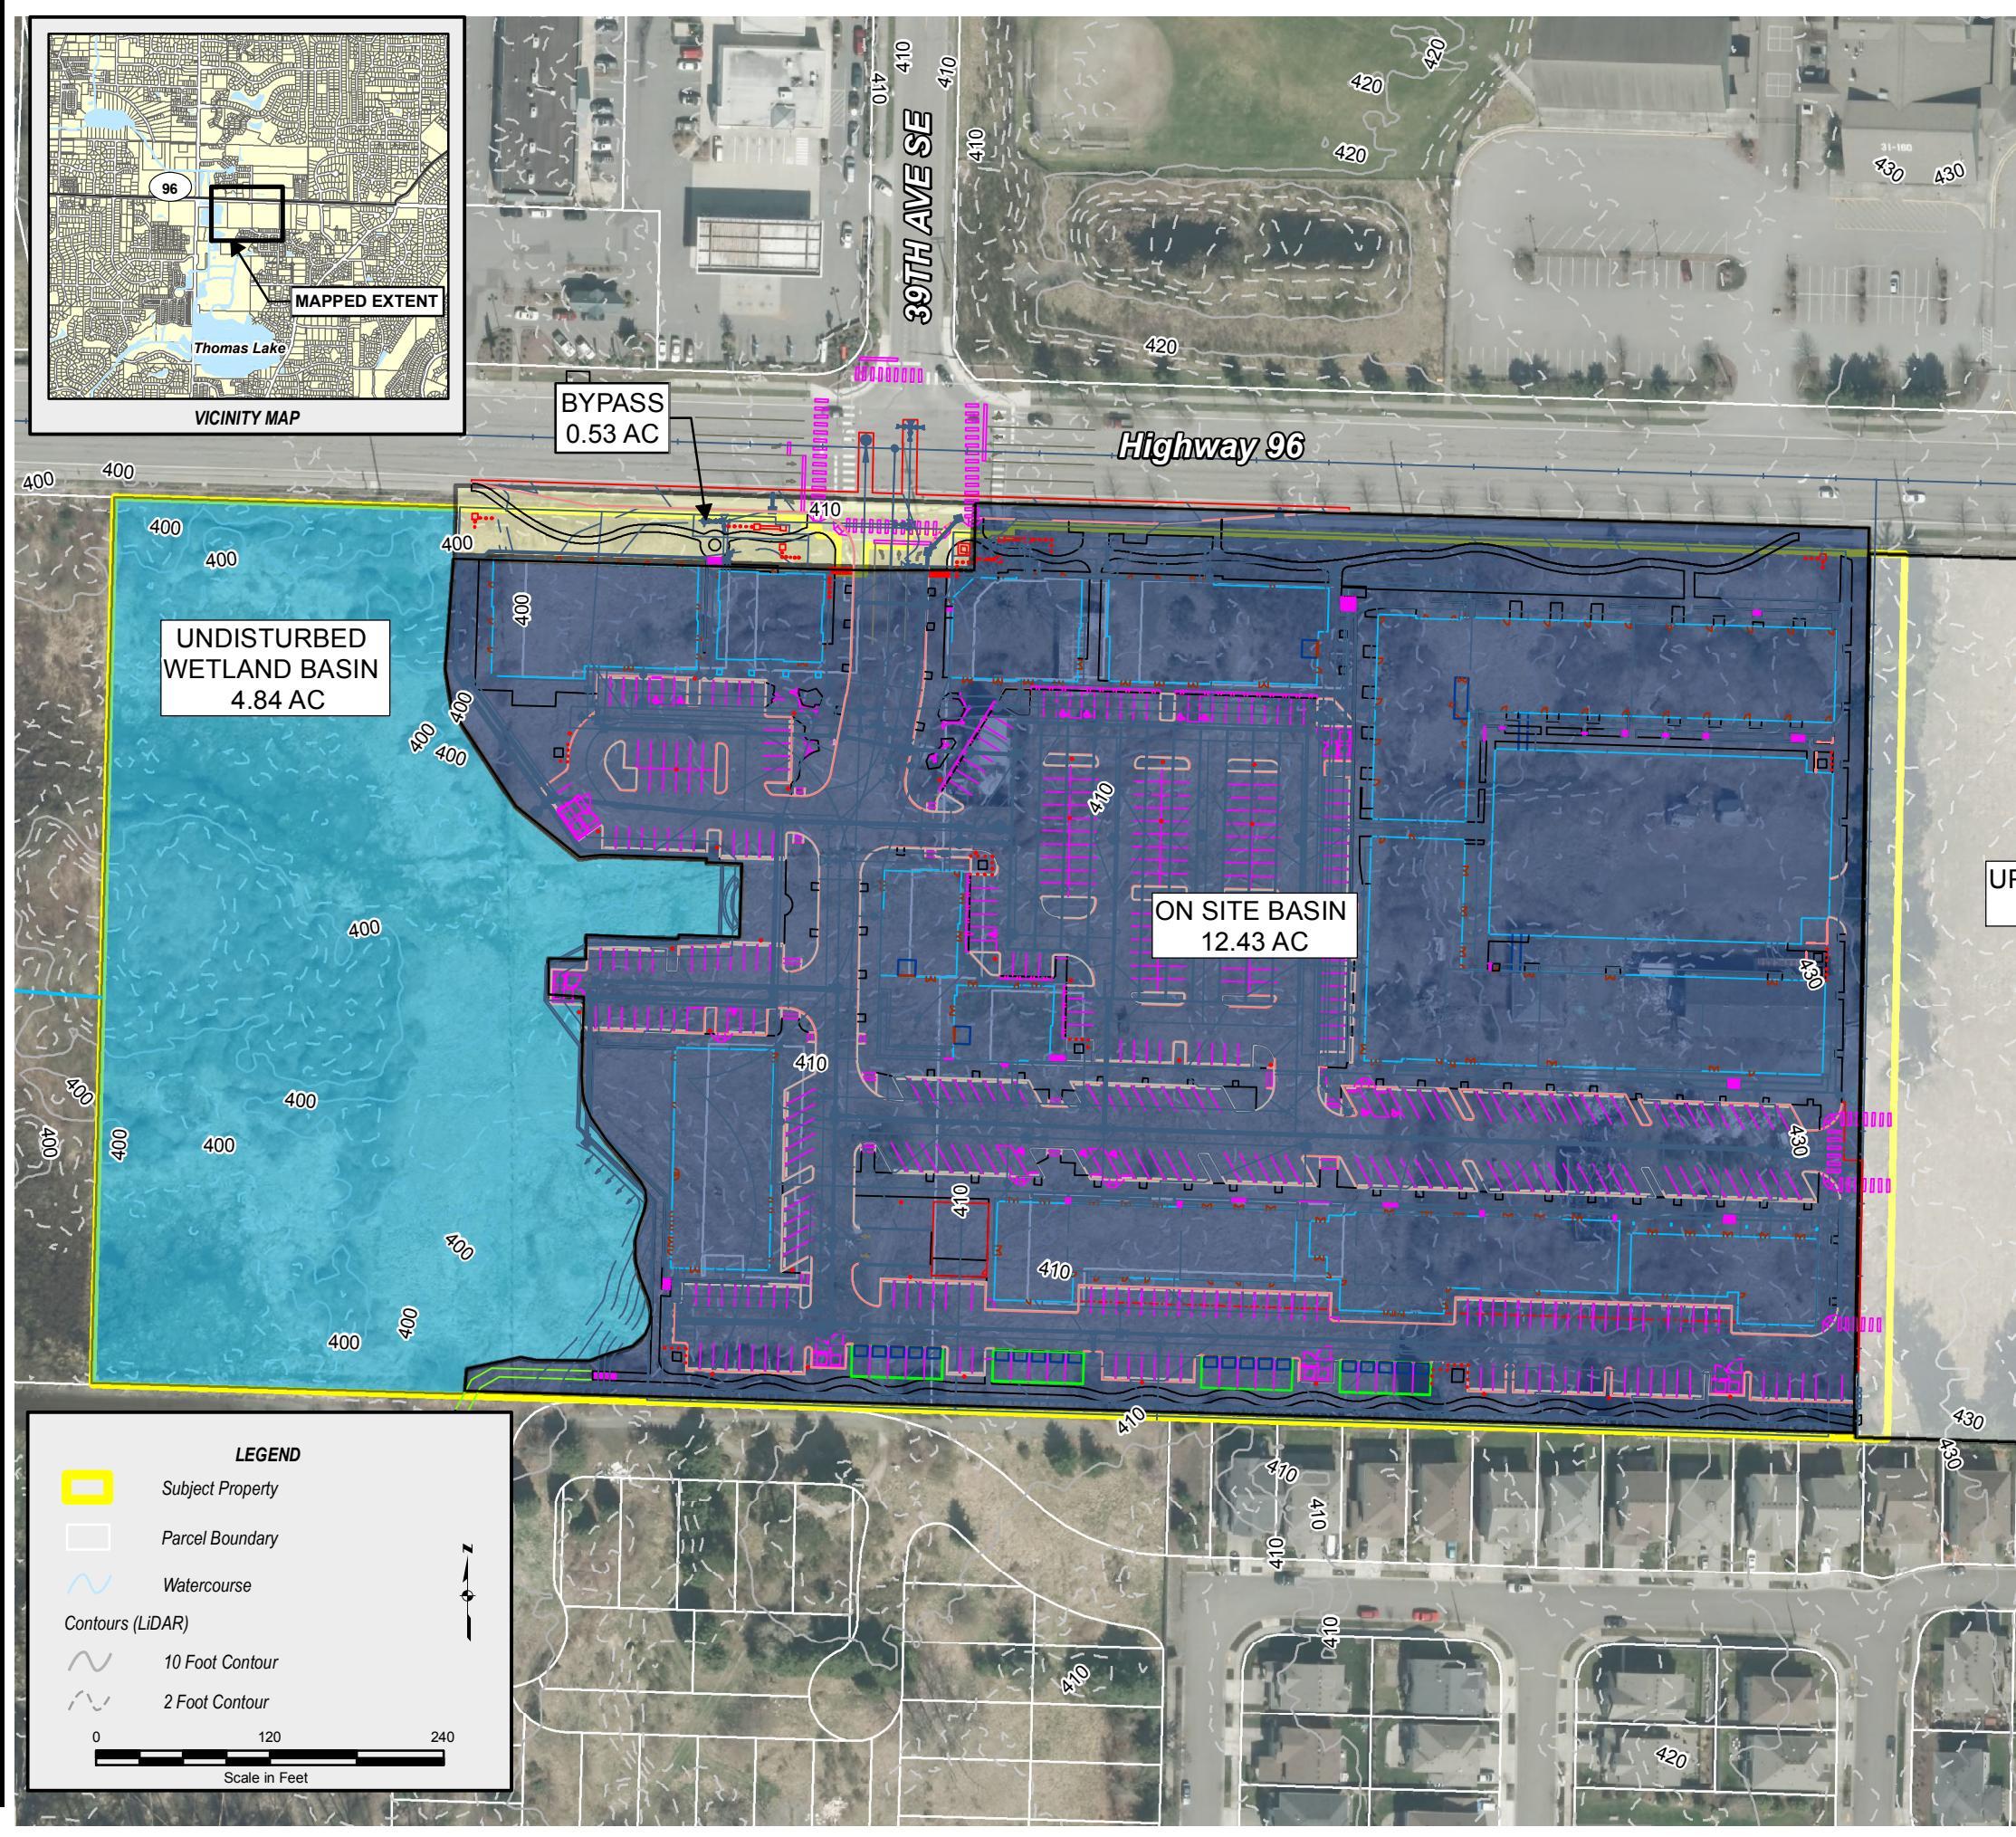
The total amount of developed and disturbed area is approximately 12.96 acres. The developed commercial site includes a combination of commercial and residential buildings, roadways, parking lots for all the building, landscaping, and associated utilities. 12.96 acres of this onsite developed and disturbed area will be subject to the water quality and flow control. The upstream basin is developed with drive aisles, parking, landscape/lawn areas, and apartment buildings. See Figure 6.1 in this section for the Developed Conditions Map.

Impervious	3.17 Acres
Pervious	0.65 Acres
Total	3.82 Acres

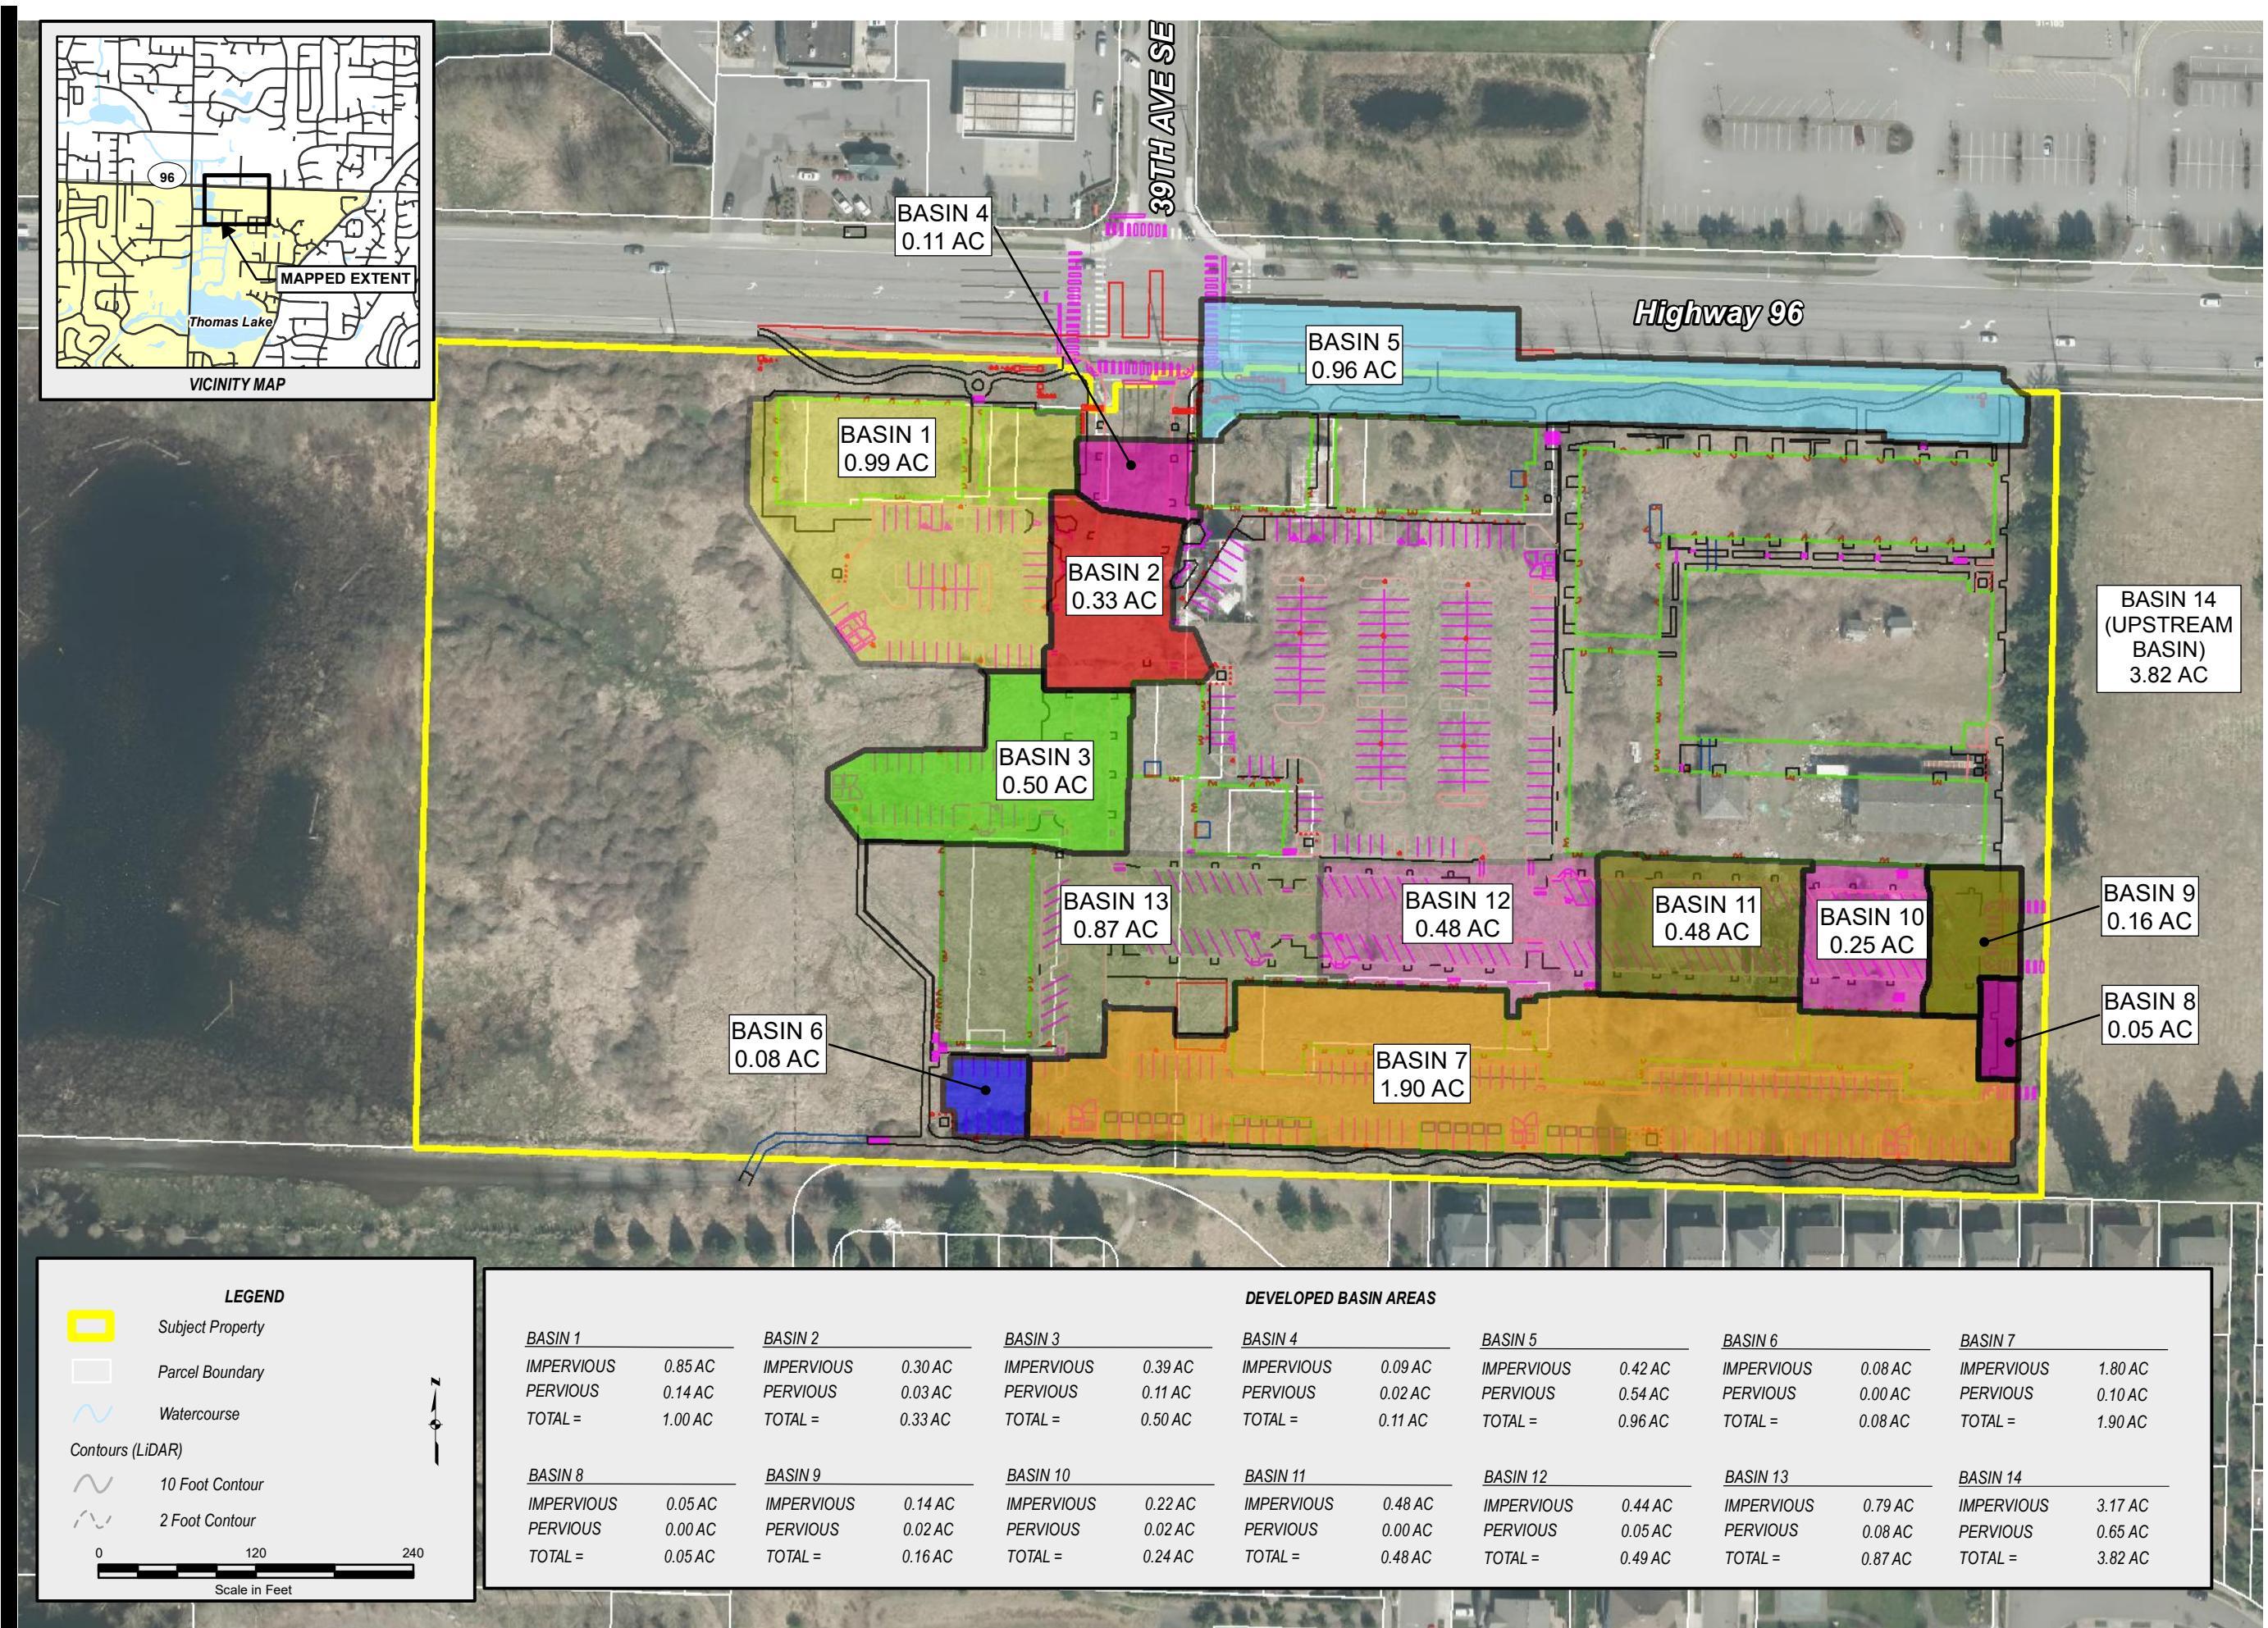
Impervious	3.17 Acres
Lawn	0.65 Acres

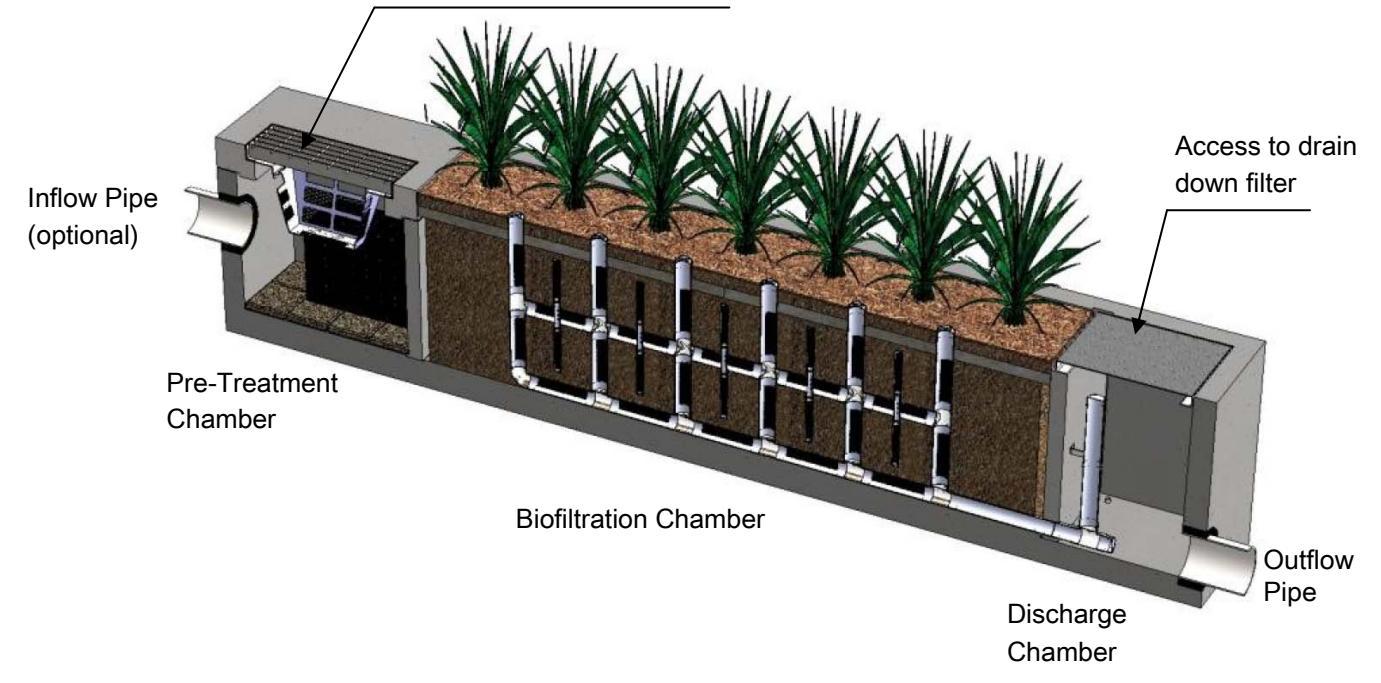
### System Diagram

Access to screening device, separation chamber and cartridge filter

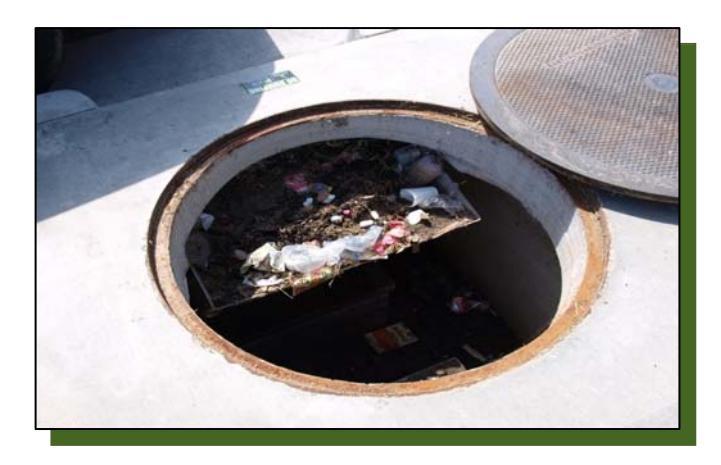
### **Screening Device**

The screening device is located directly under the manhole or grate over the Pre-Treatment Chamber. It's mounted directly underneath for easy access and cleaning. Device can be cleaned by hand or with a vacuum truck.

- 1. Remove grate or manhole cover to gain access to the screening device in the Pre-Treatment Chamber. Vault type units do not have screening device. Maintenance can be performed without entry.
- 2. Remove all pollutants collected by the screening device. Removal can be done manually or with the use of a vacuum truck. The hose of the vacuum truck will not damage the screening device.
- 3. Screening device can easily be removed from the Pre-Treatment Chamber to gain access to separation chamber and media filters below. Replace grate or manhole cover when completed.

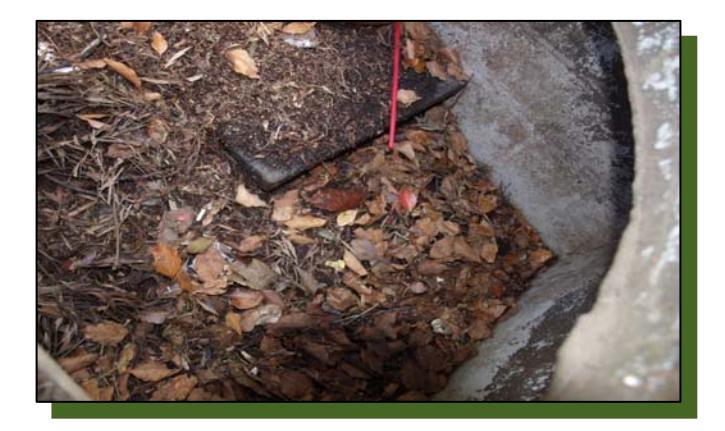
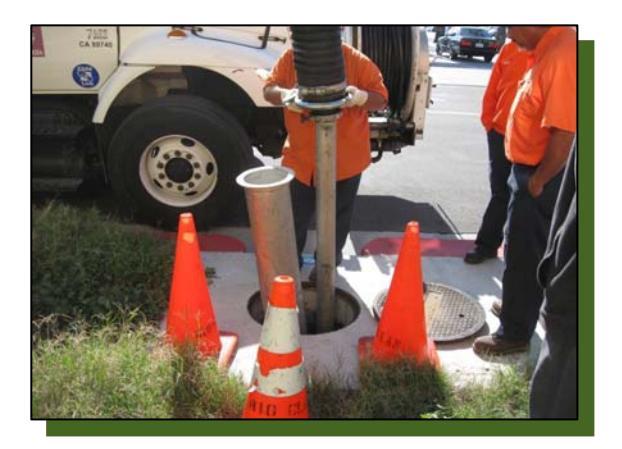
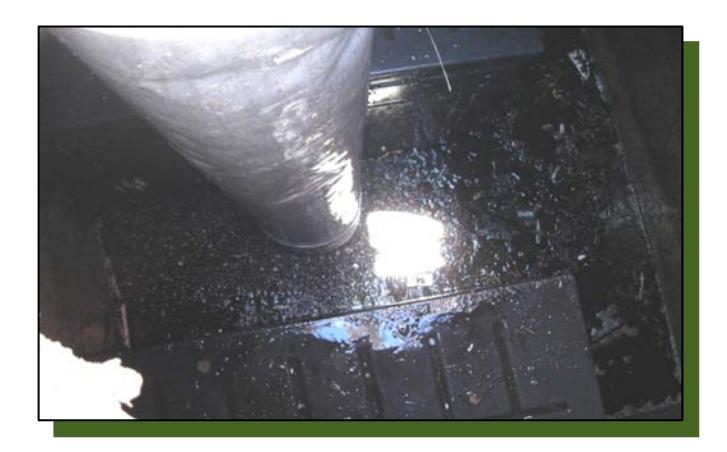
#### Separation Chamber

The separation chamber is located directly beneath the screening device. It can be quickly cleaned using a vacuum truck or by hand. A pressure washer is useful to assist in the cleaning process.

- 1. Perform maintenance procedures of screening device listed above before maintaining the separation chamber.
- 2. With a pressure washer spray down pollutants accumulated on walls and cartridge filters.
- 3. Vacuum out Separation Chamber and remove all accumulated pollutants. Replace screening device, grate or manhole cover when completed.

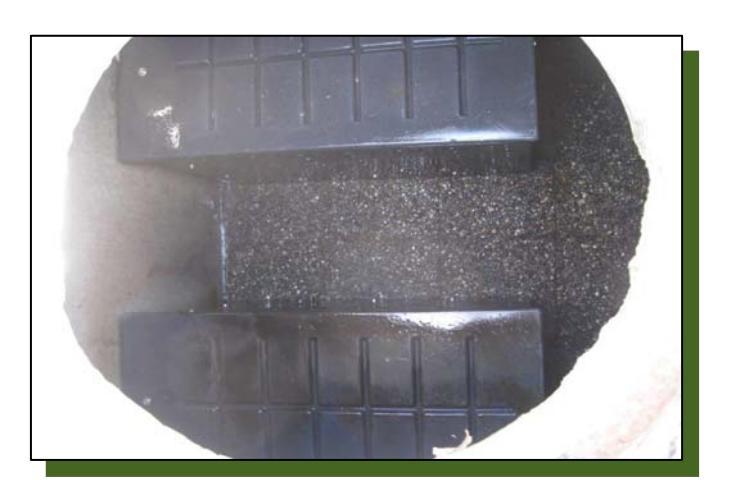
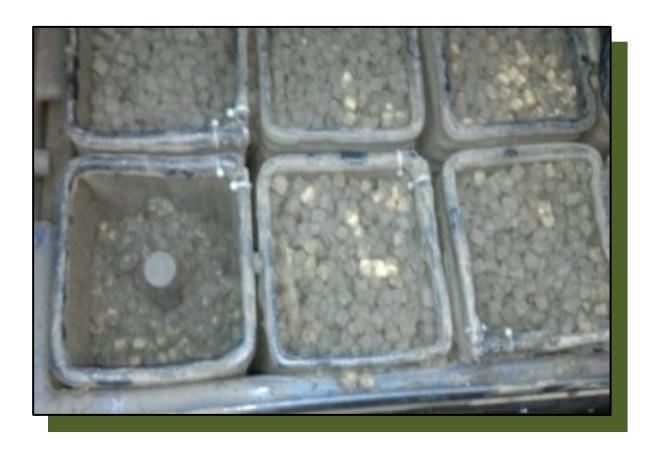
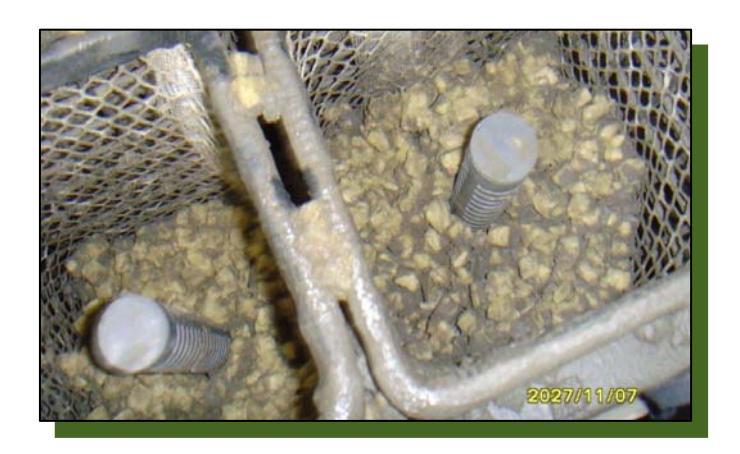
### Cartridge Filters

The cartridge filters are located in the Pre-Treatment chamber connected to the wall adjacent to the biofiltration chamber. The cartridges have removable tops to access the individual media filters. Once the cartridge is open media can be easily removed and replaced by hand or a vacuum truck.

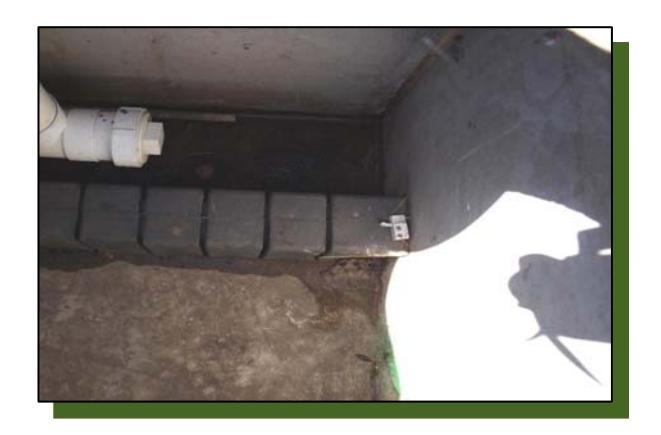
### Drain Down Filter

The drain down filter is located in the Discharge Chamber. The drain filter unlocks from the wall mount and hinges up. Remove filter block and replace with new block.

- 1. Remove hatch or manhole cover over discharge chamber and enter chamber.
- 2. Unlock and lift drain down filter housing and remove old media block. Replace with new media block. Lower drain down filter housing and lock into place.
- 3. Exit chamber and replace hatch or manhole cover.

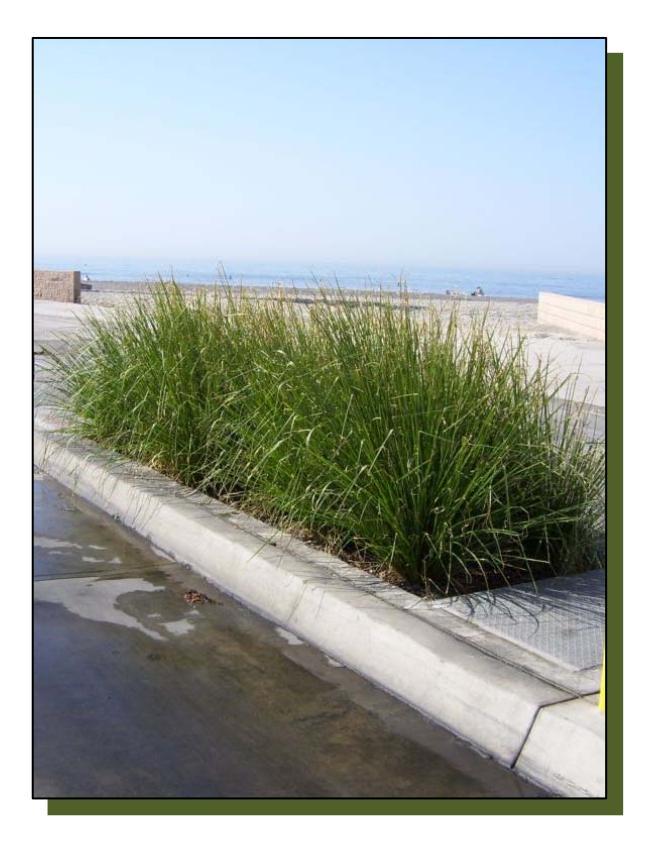
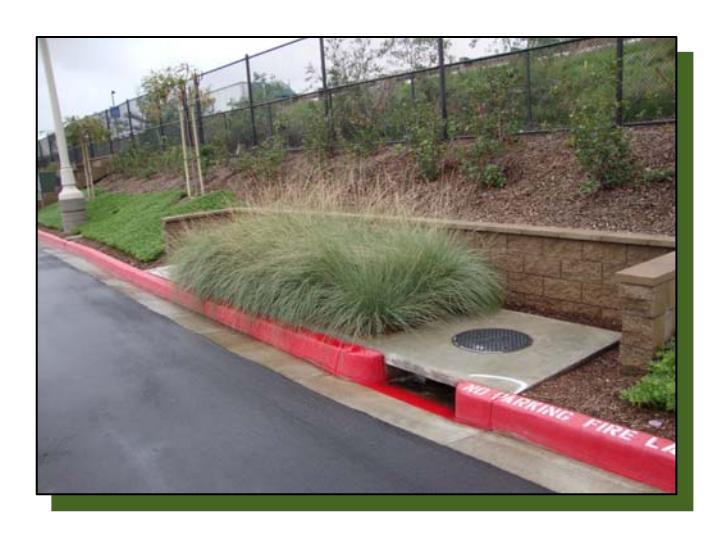
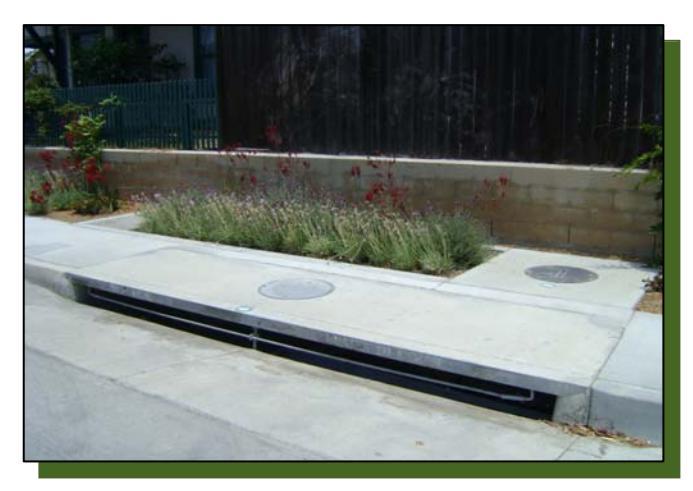
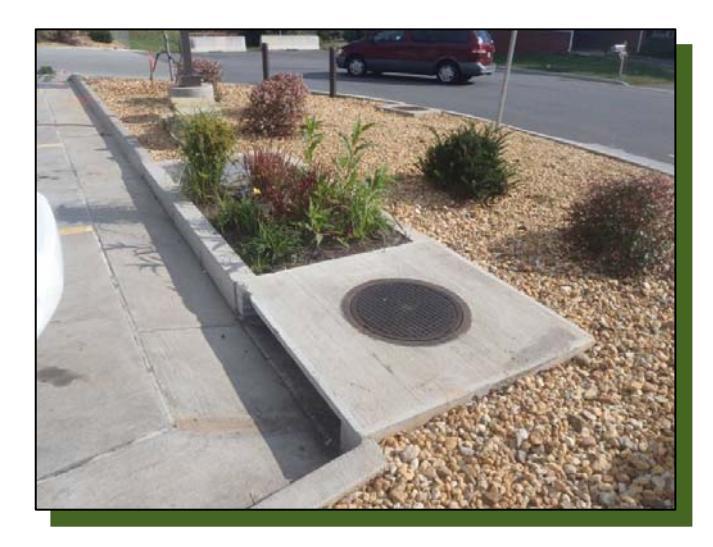
## **Trim Vegetation**

Vegetation should be maintained in the same manner as surrounding vegetation and trimmed as needed. No fertilizer shall be used on the plants. Irrigation per the recommendation of the manufacturer and or landscape architect. Different types of vegetation requires different amounts of irrigation.

- 5. No fertilizer shall be used in the Biofiltration Chamber.
- 6. Irrigation should be provided as recommended by manufacturer and/or landscape architect. Amount of irrigation required is dependent on plant species. Some plants may require irrigation.
